DeLorean Crash Test No. 1
36 MPH Frontal Barrier Test

4.2 Crash Test No. 2

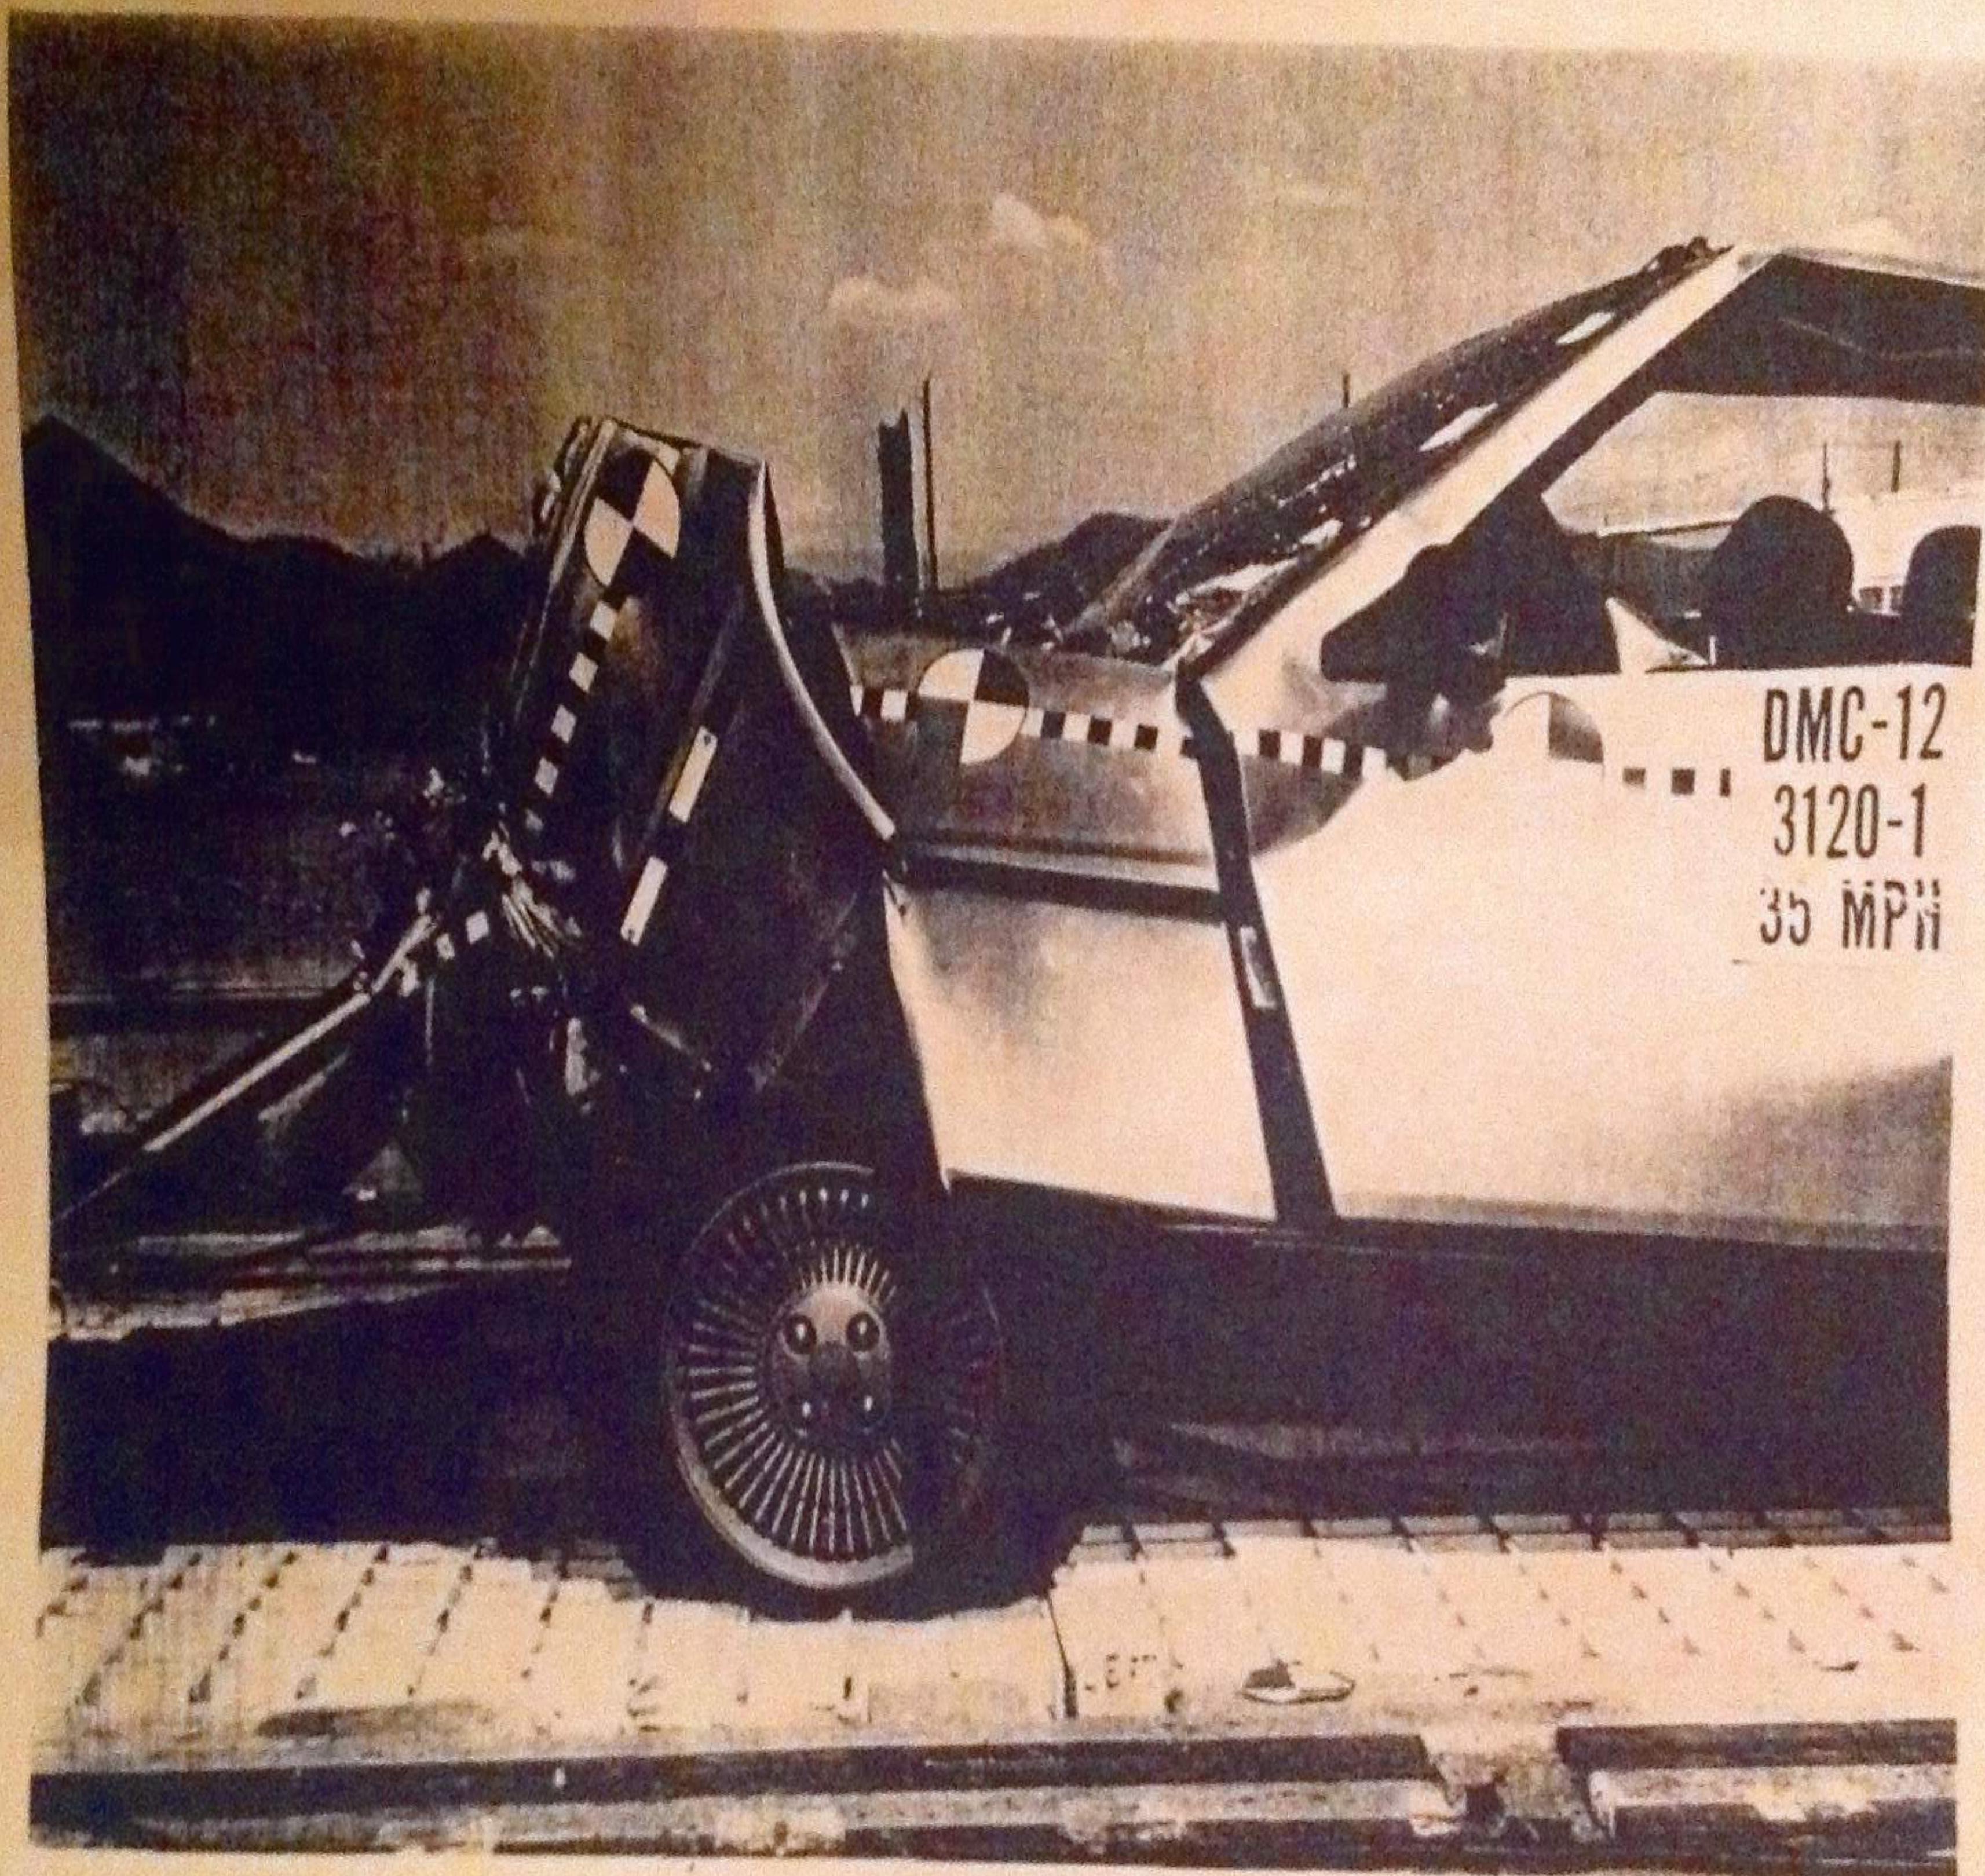
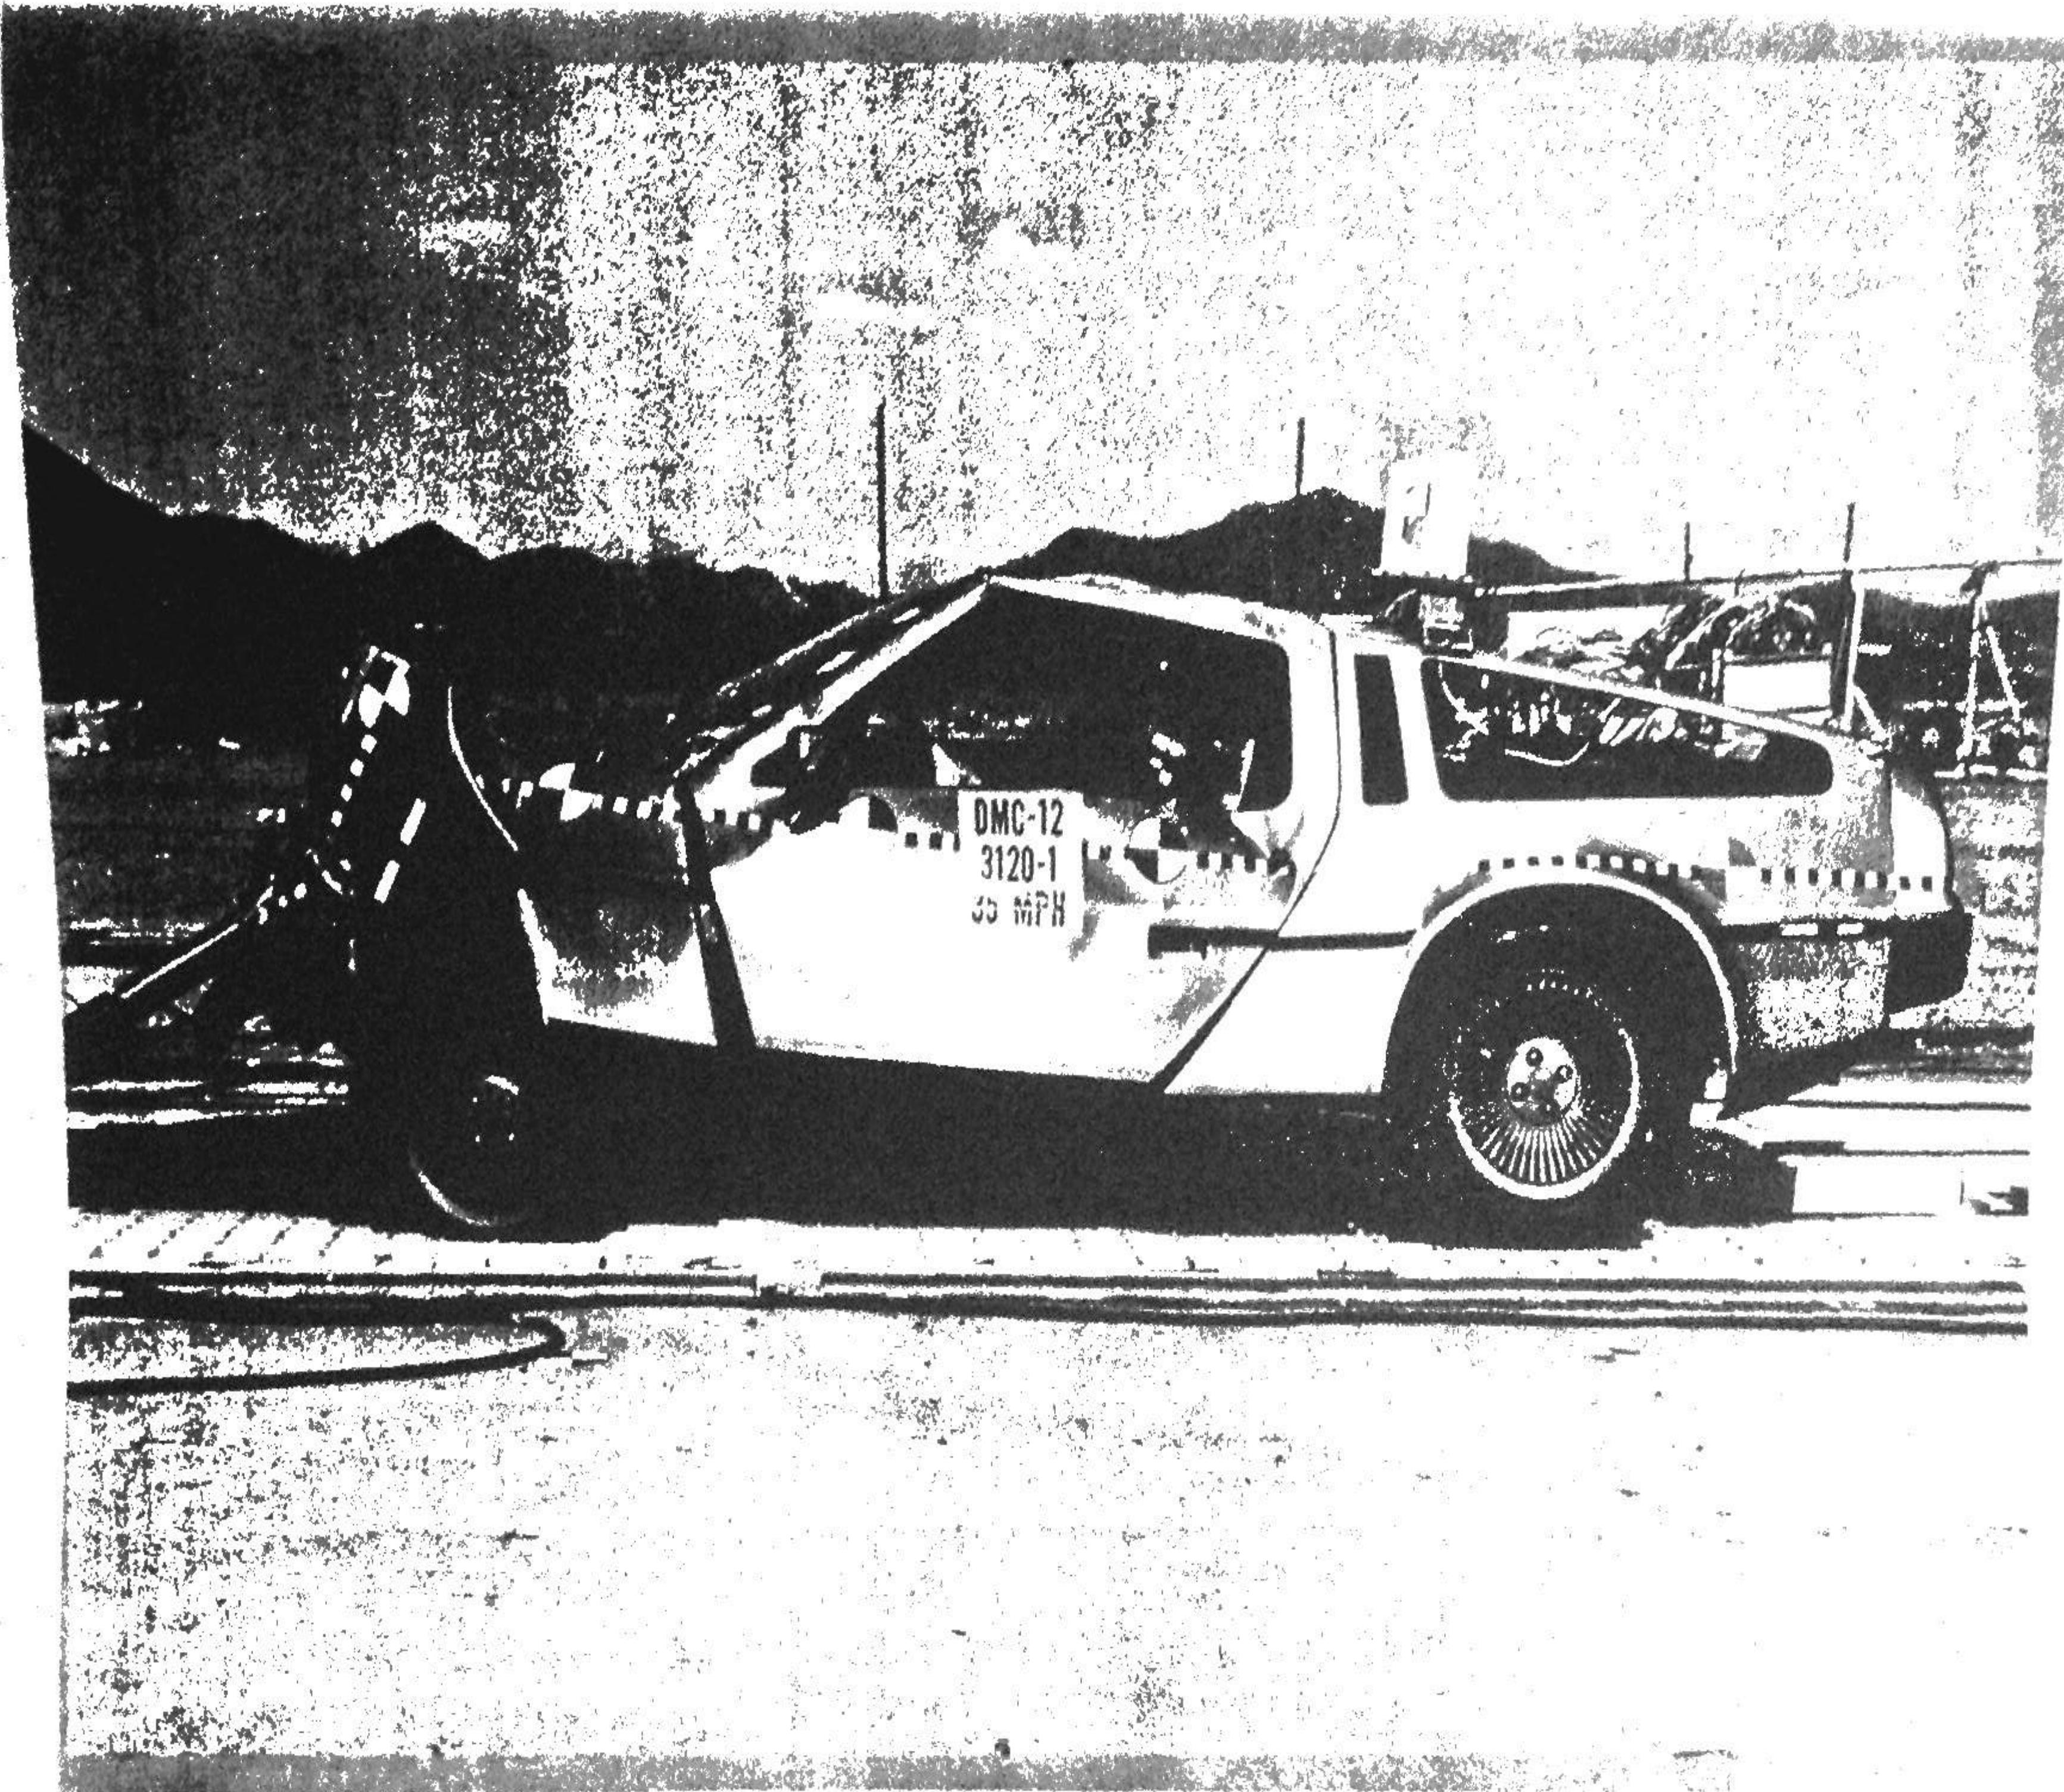
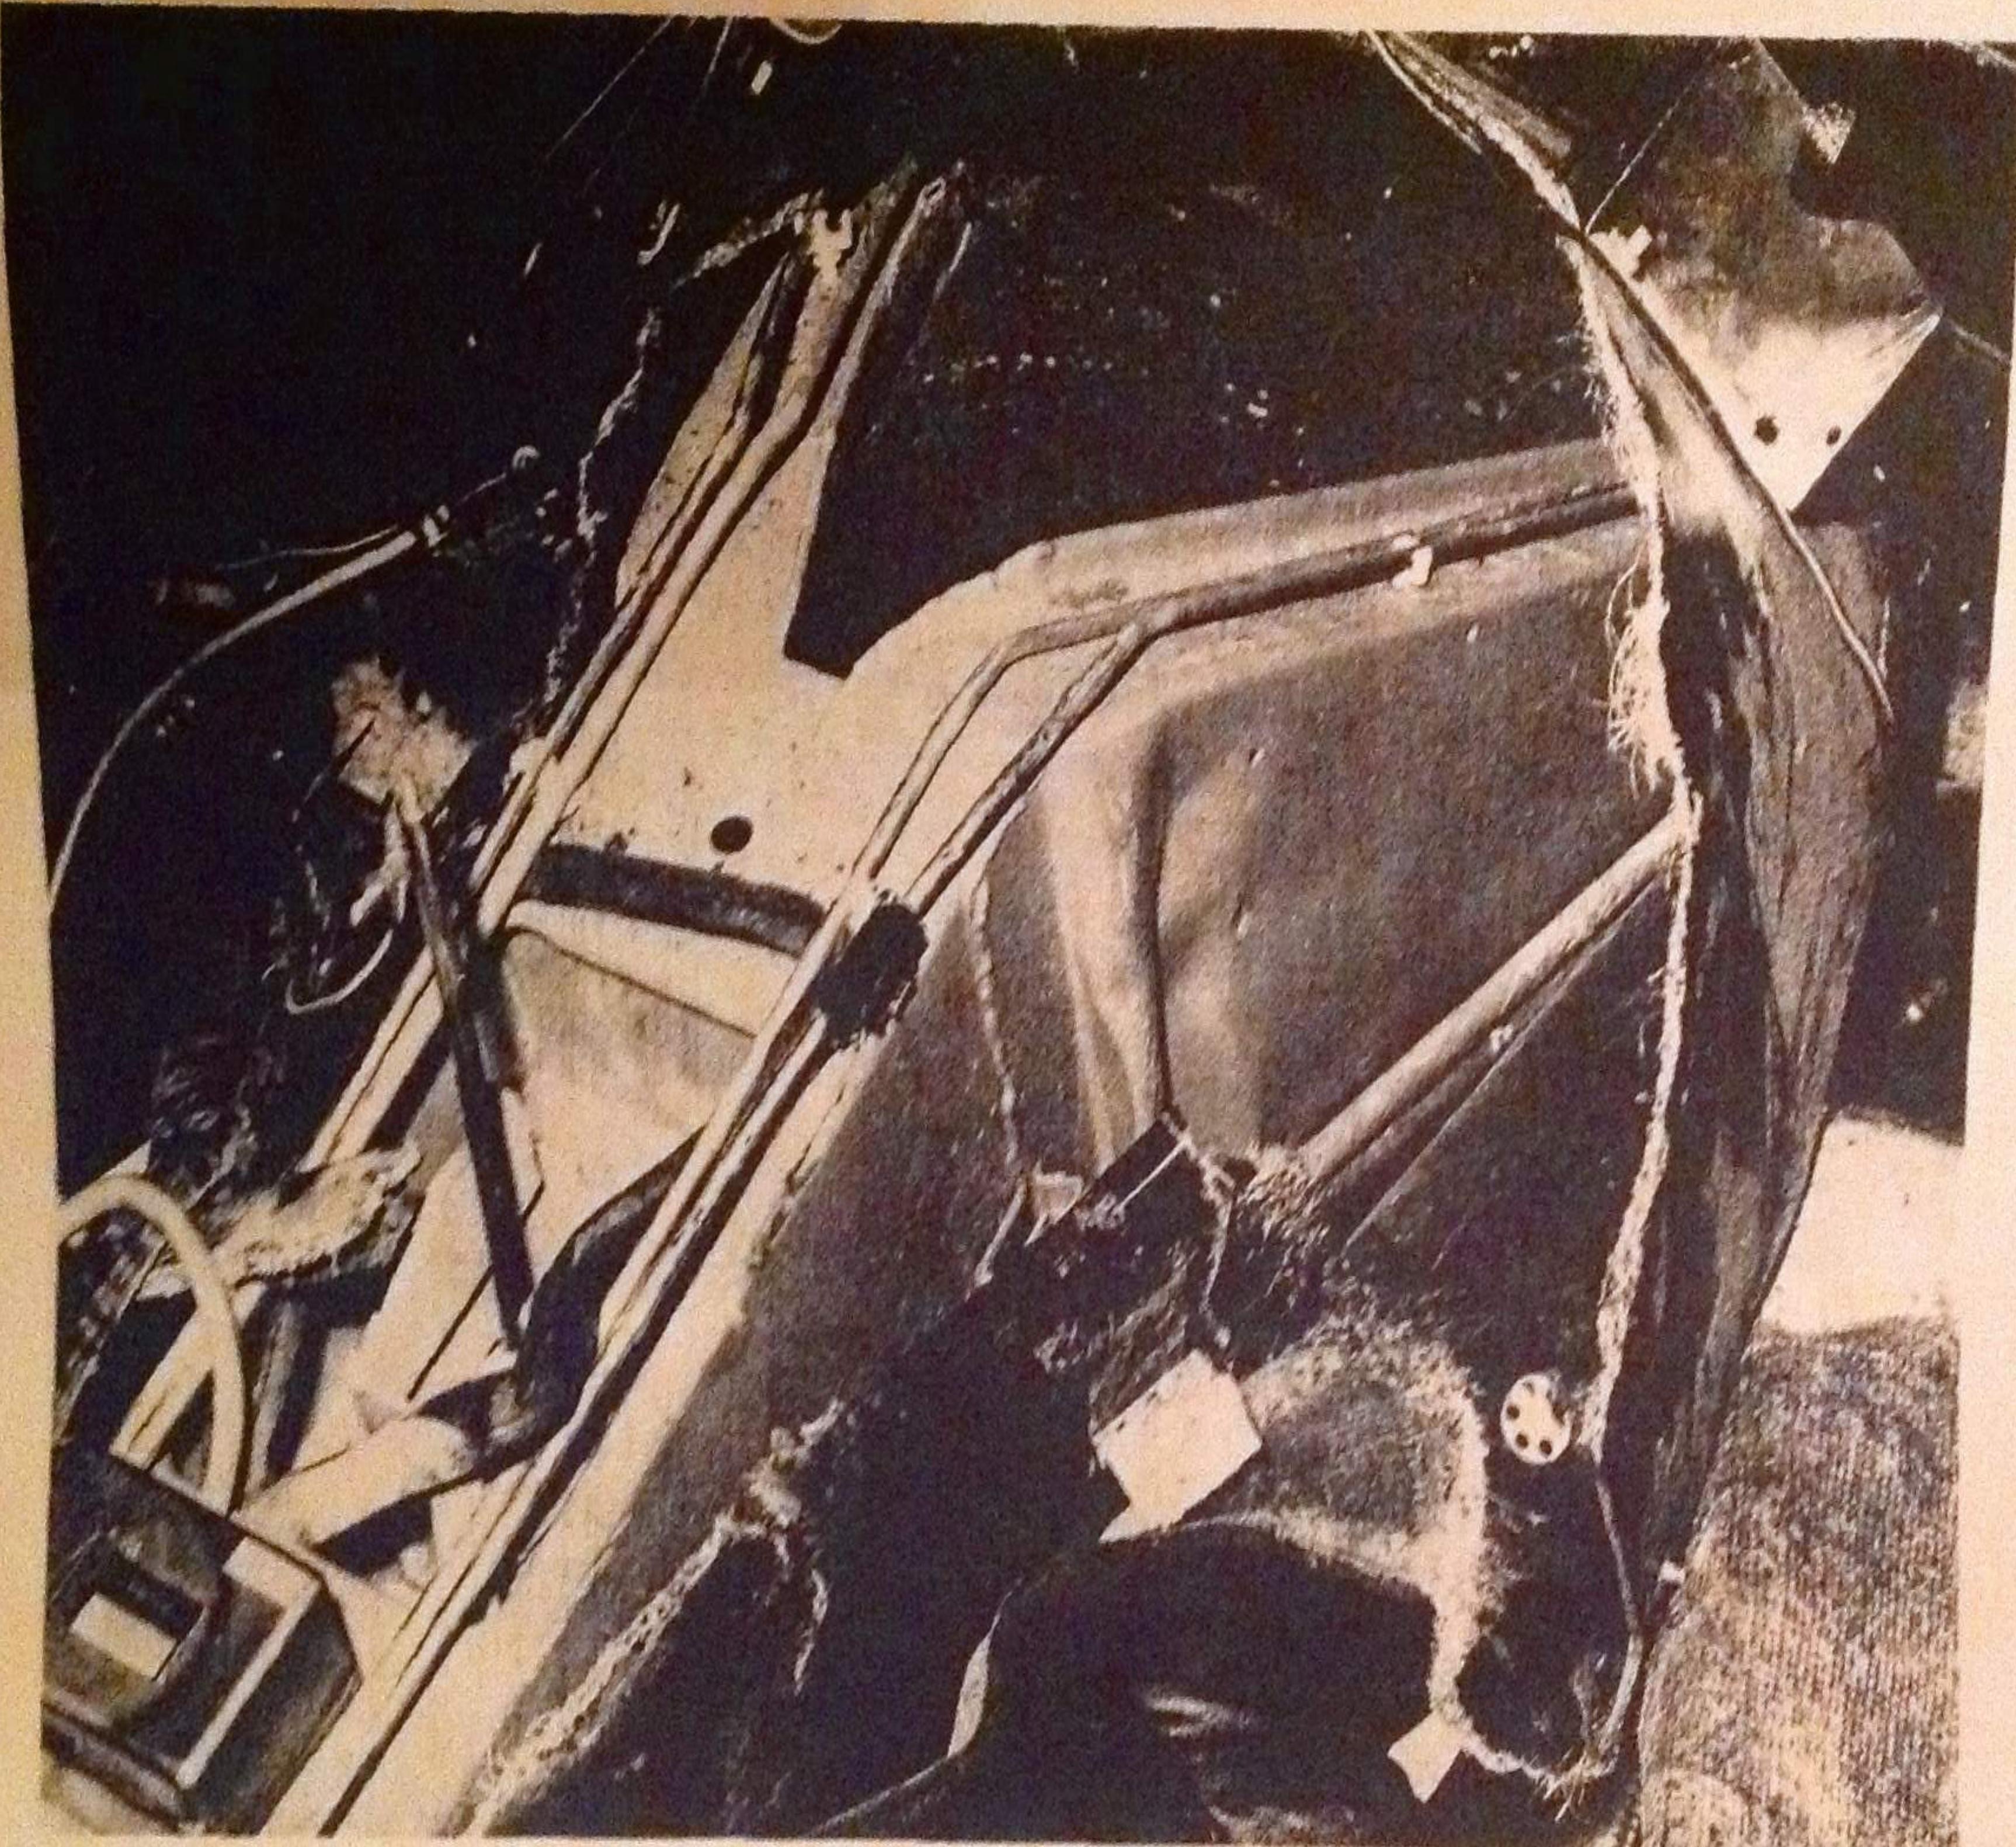
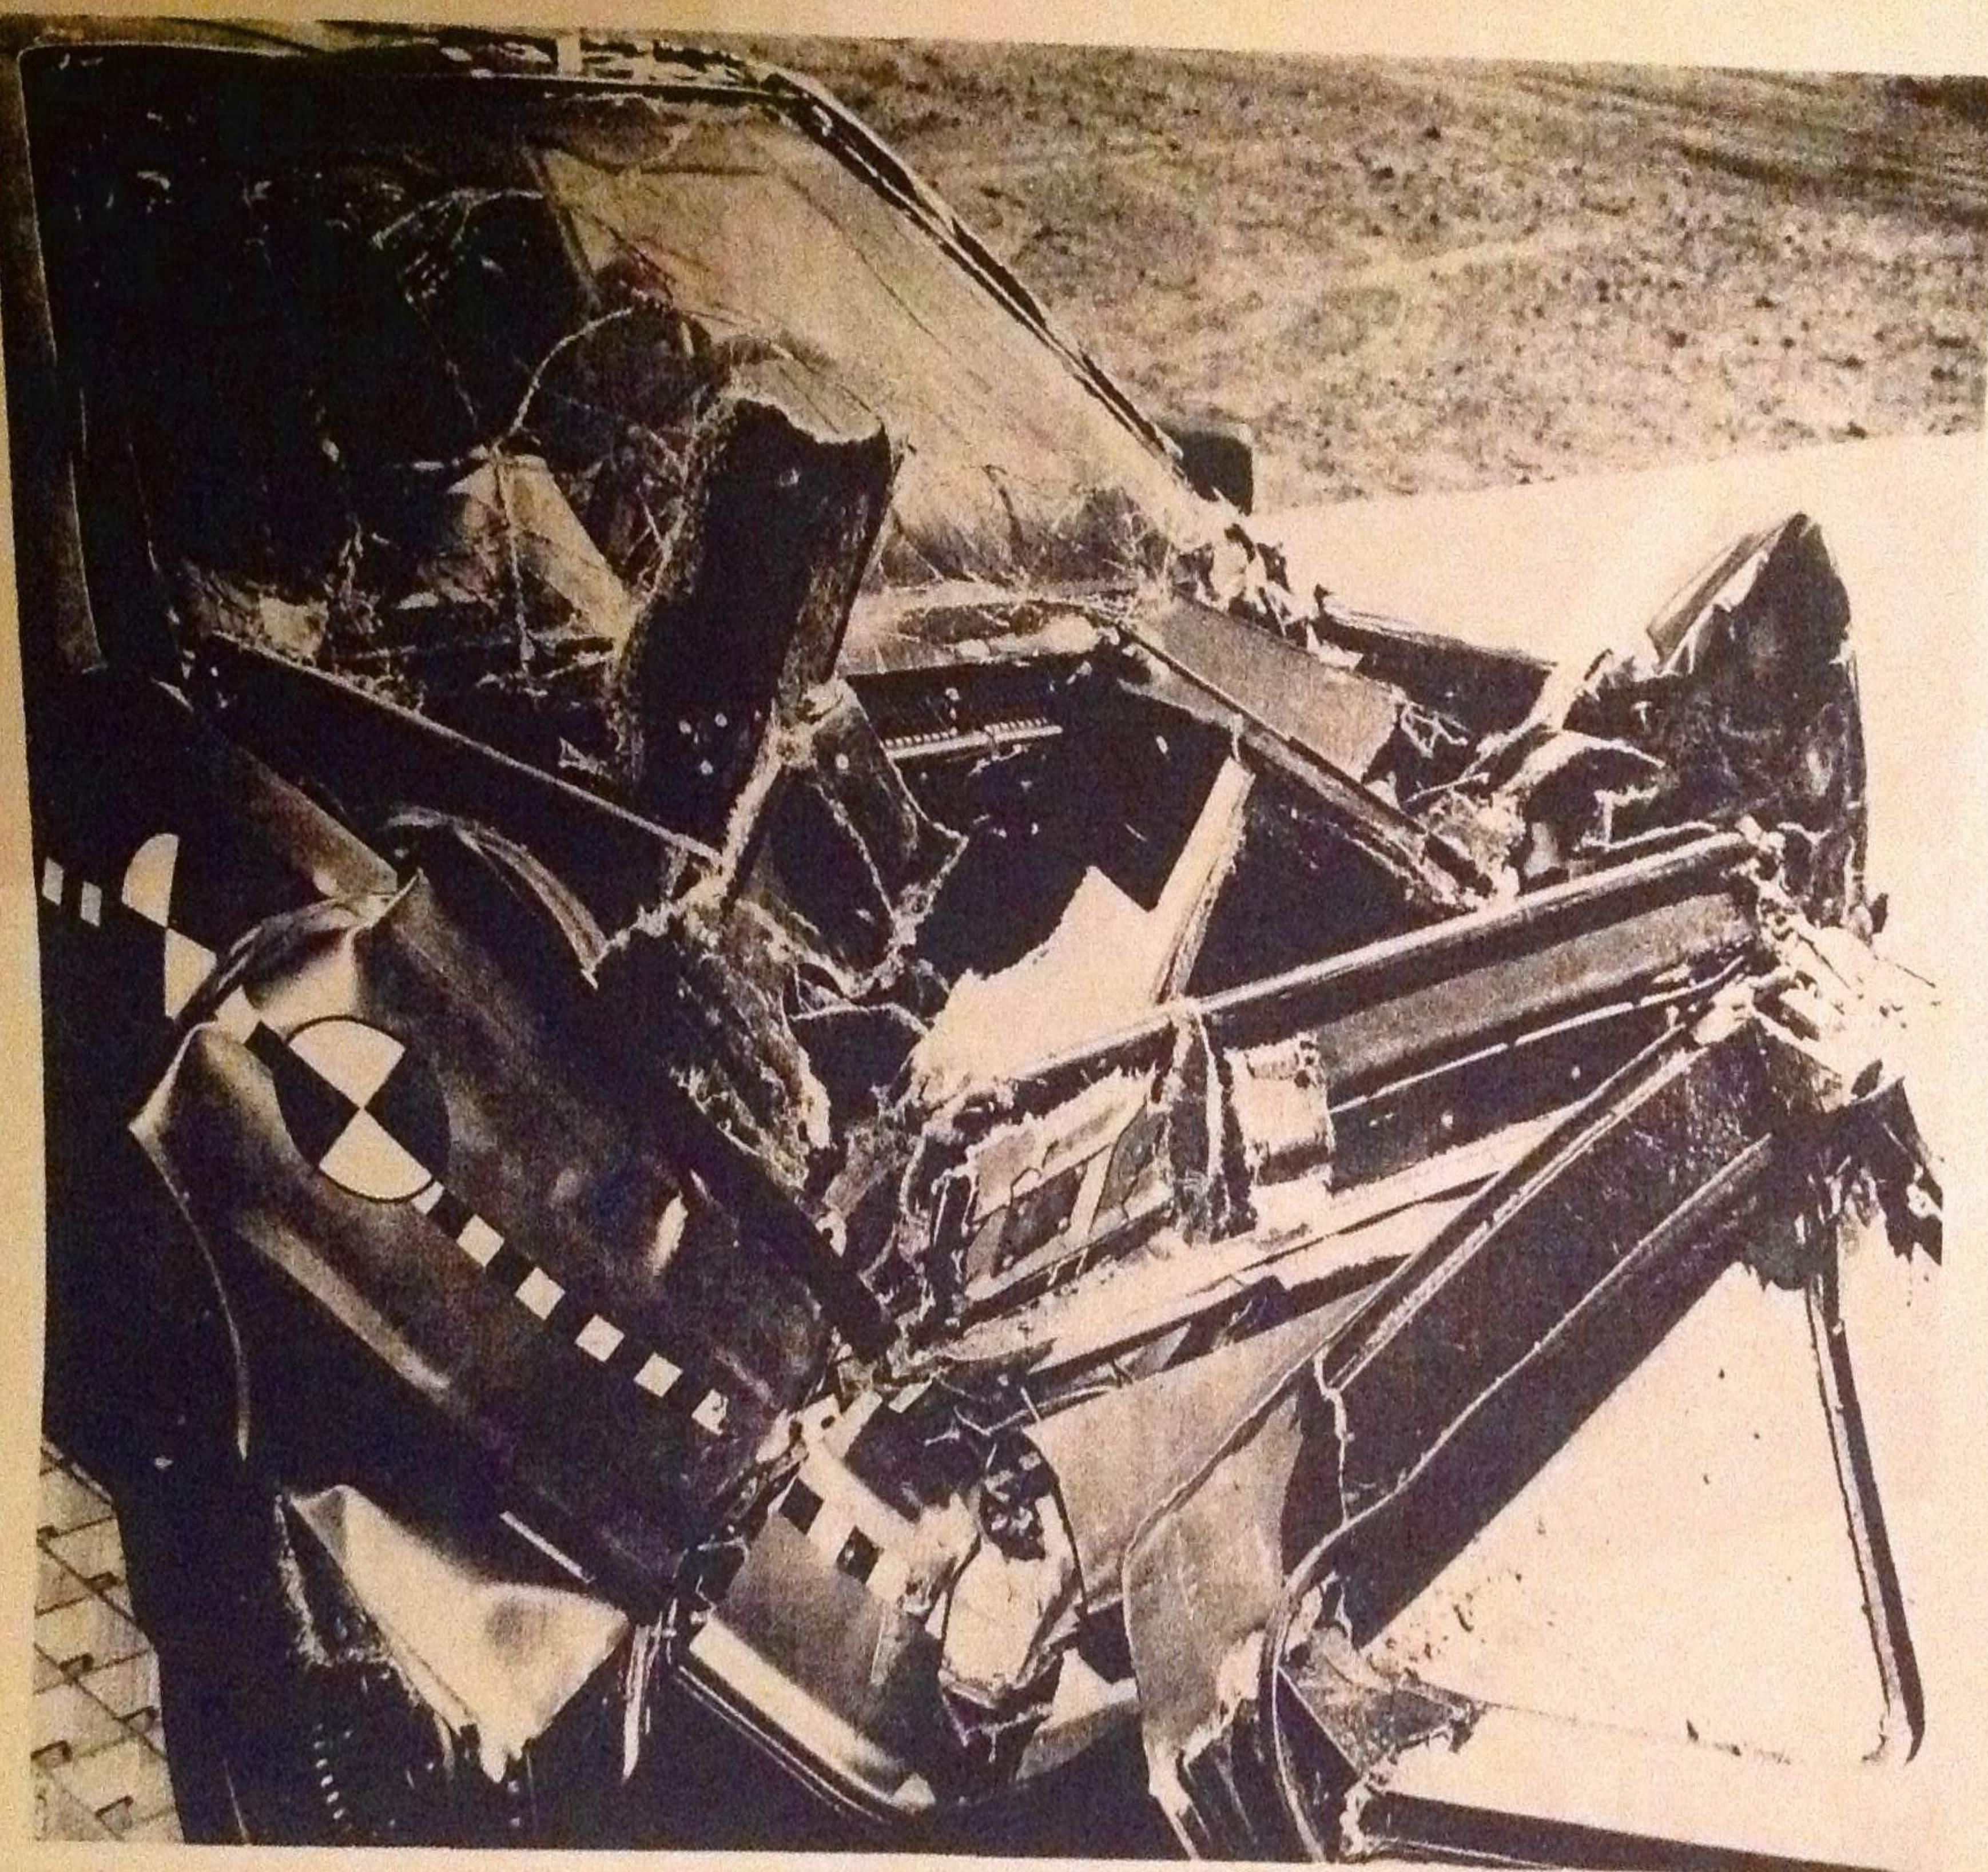
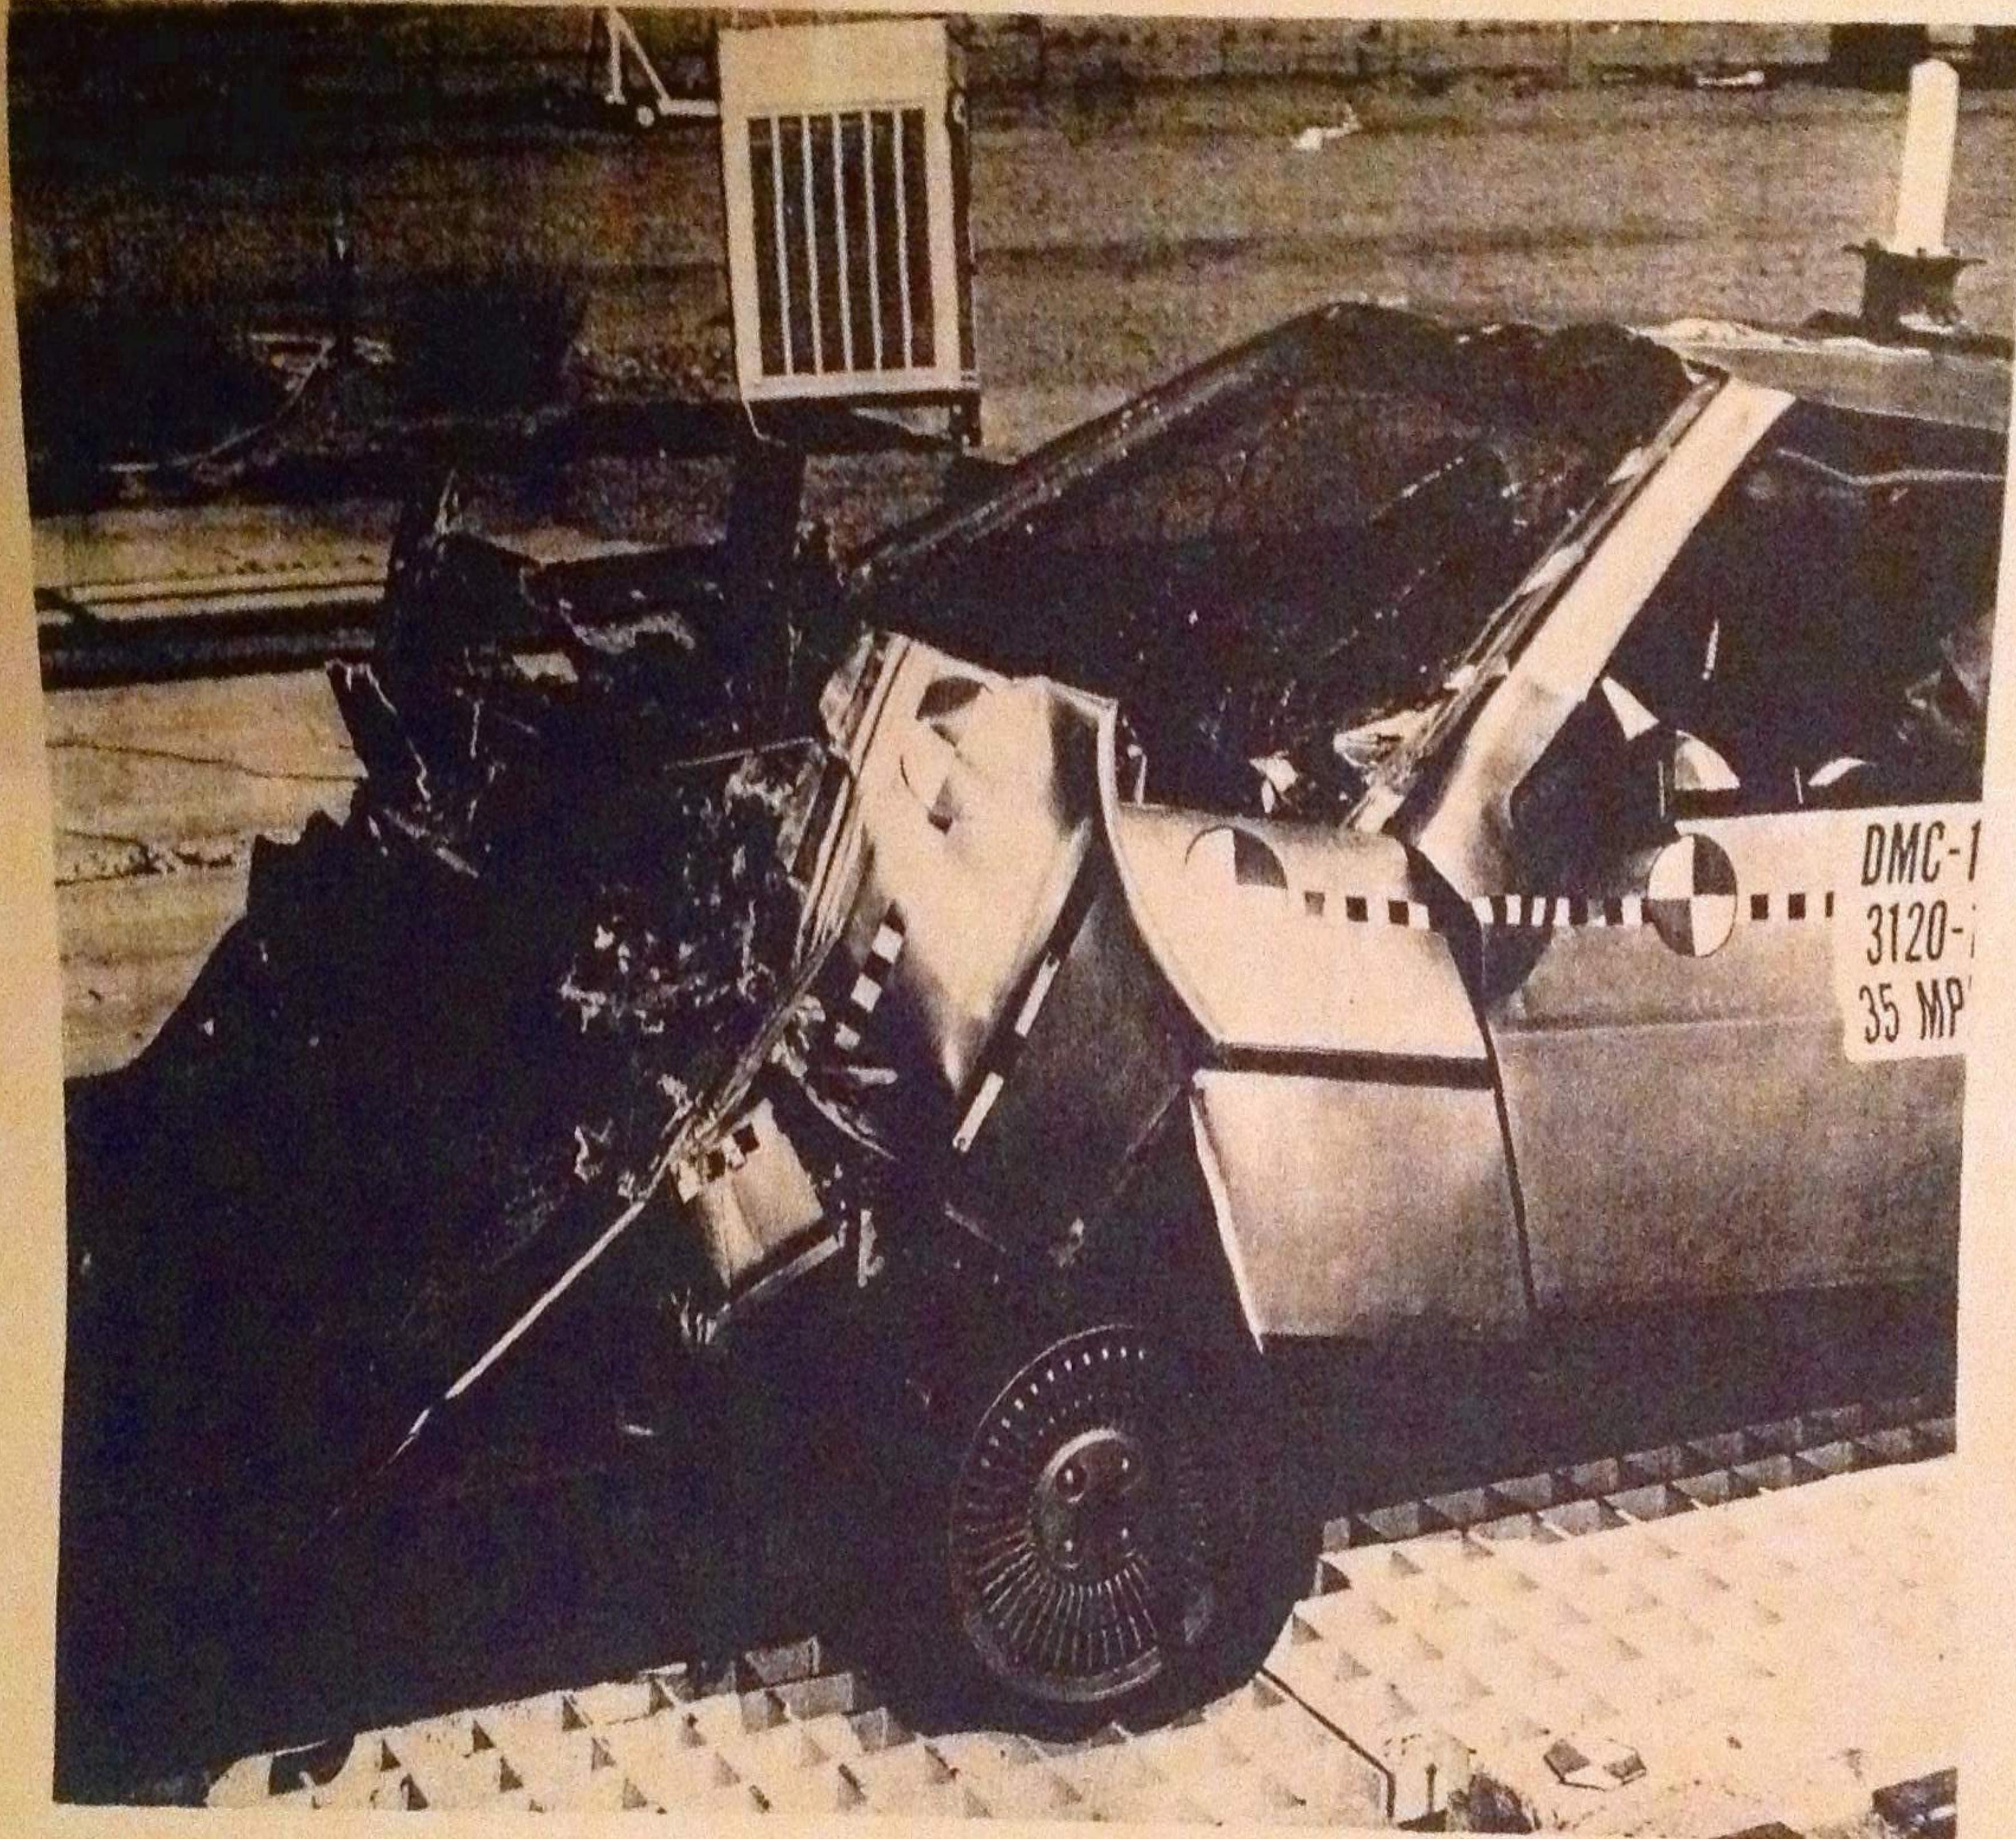
Figures 24 through 34 show the vehicle, dummies and restraint systems following the crash. There was only light-to-moderate structural intrusion into the passenger compartment and, what little there was, was confined to the lower firewall and toe-board areas.

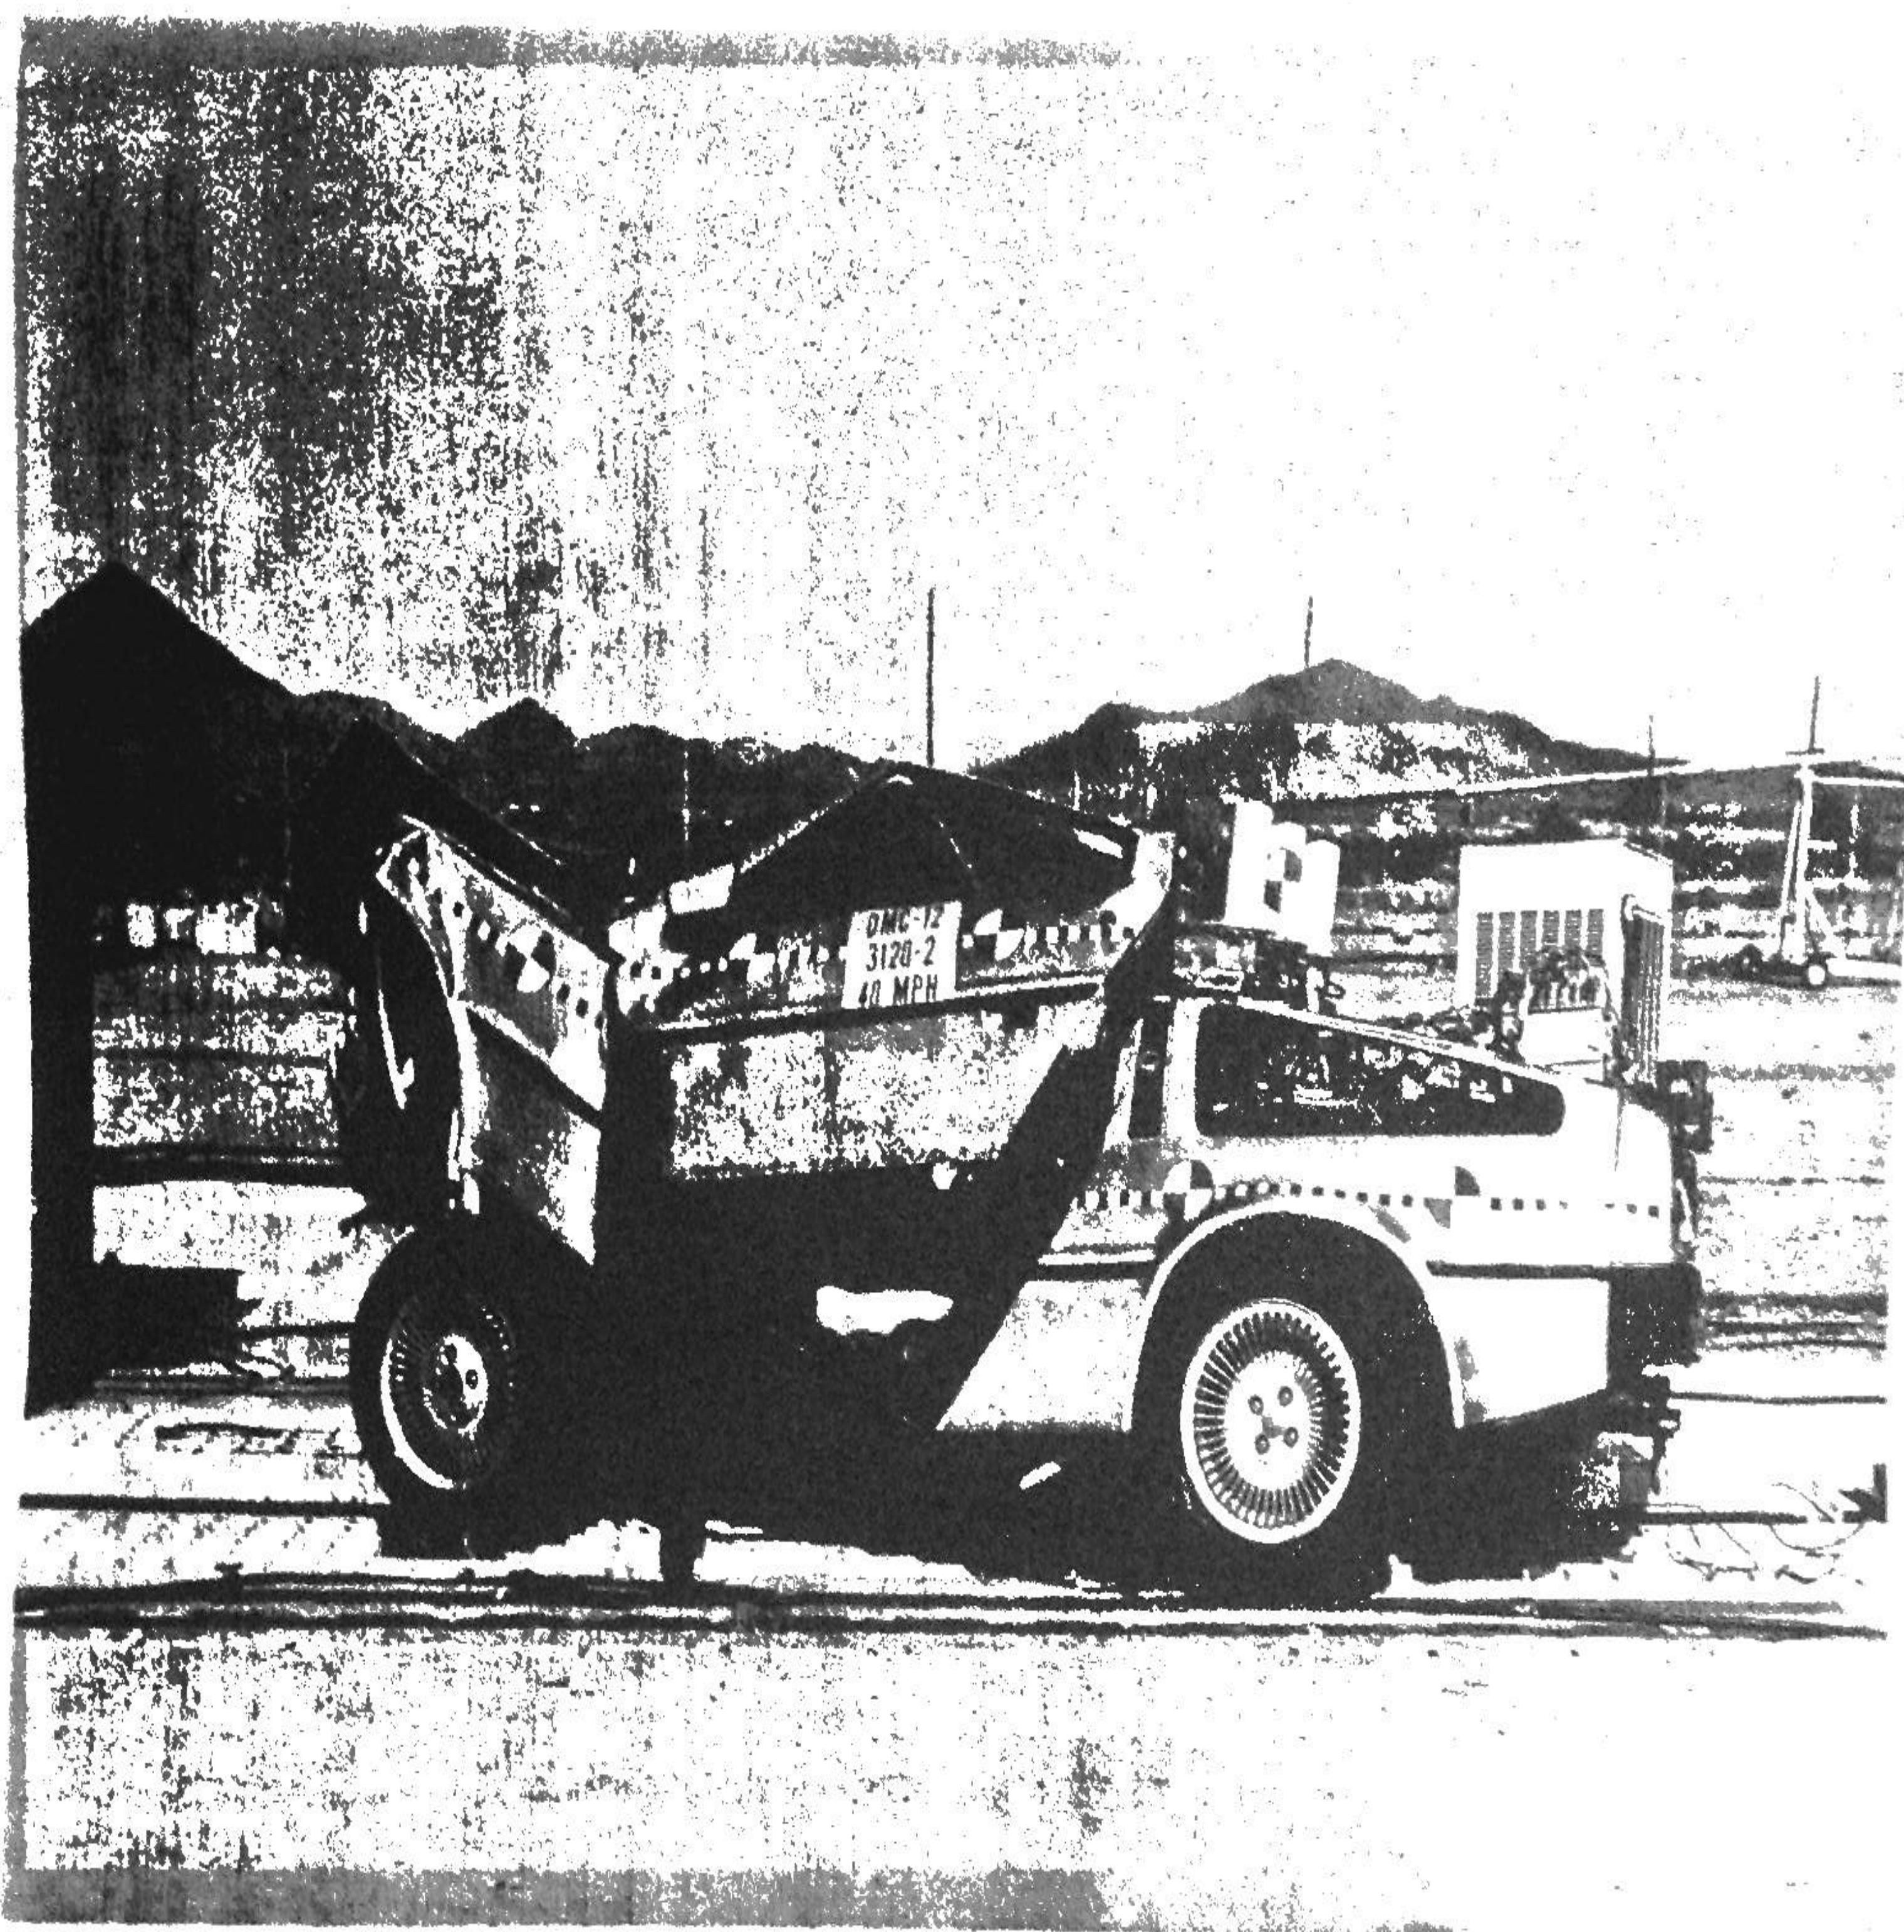
Figure 39.

Although the outward appearance of the crashed vehicle looks as if the crash was quite severe (Figures 39 through 41), the opposite is true. The vehicle crushed approximately 44 inches but the intrusion into the passenger compartment was again
