DeLorean Crash Test No. 1
36 MPH Frontal Barrier Test

4.2 Crash Test No. 2

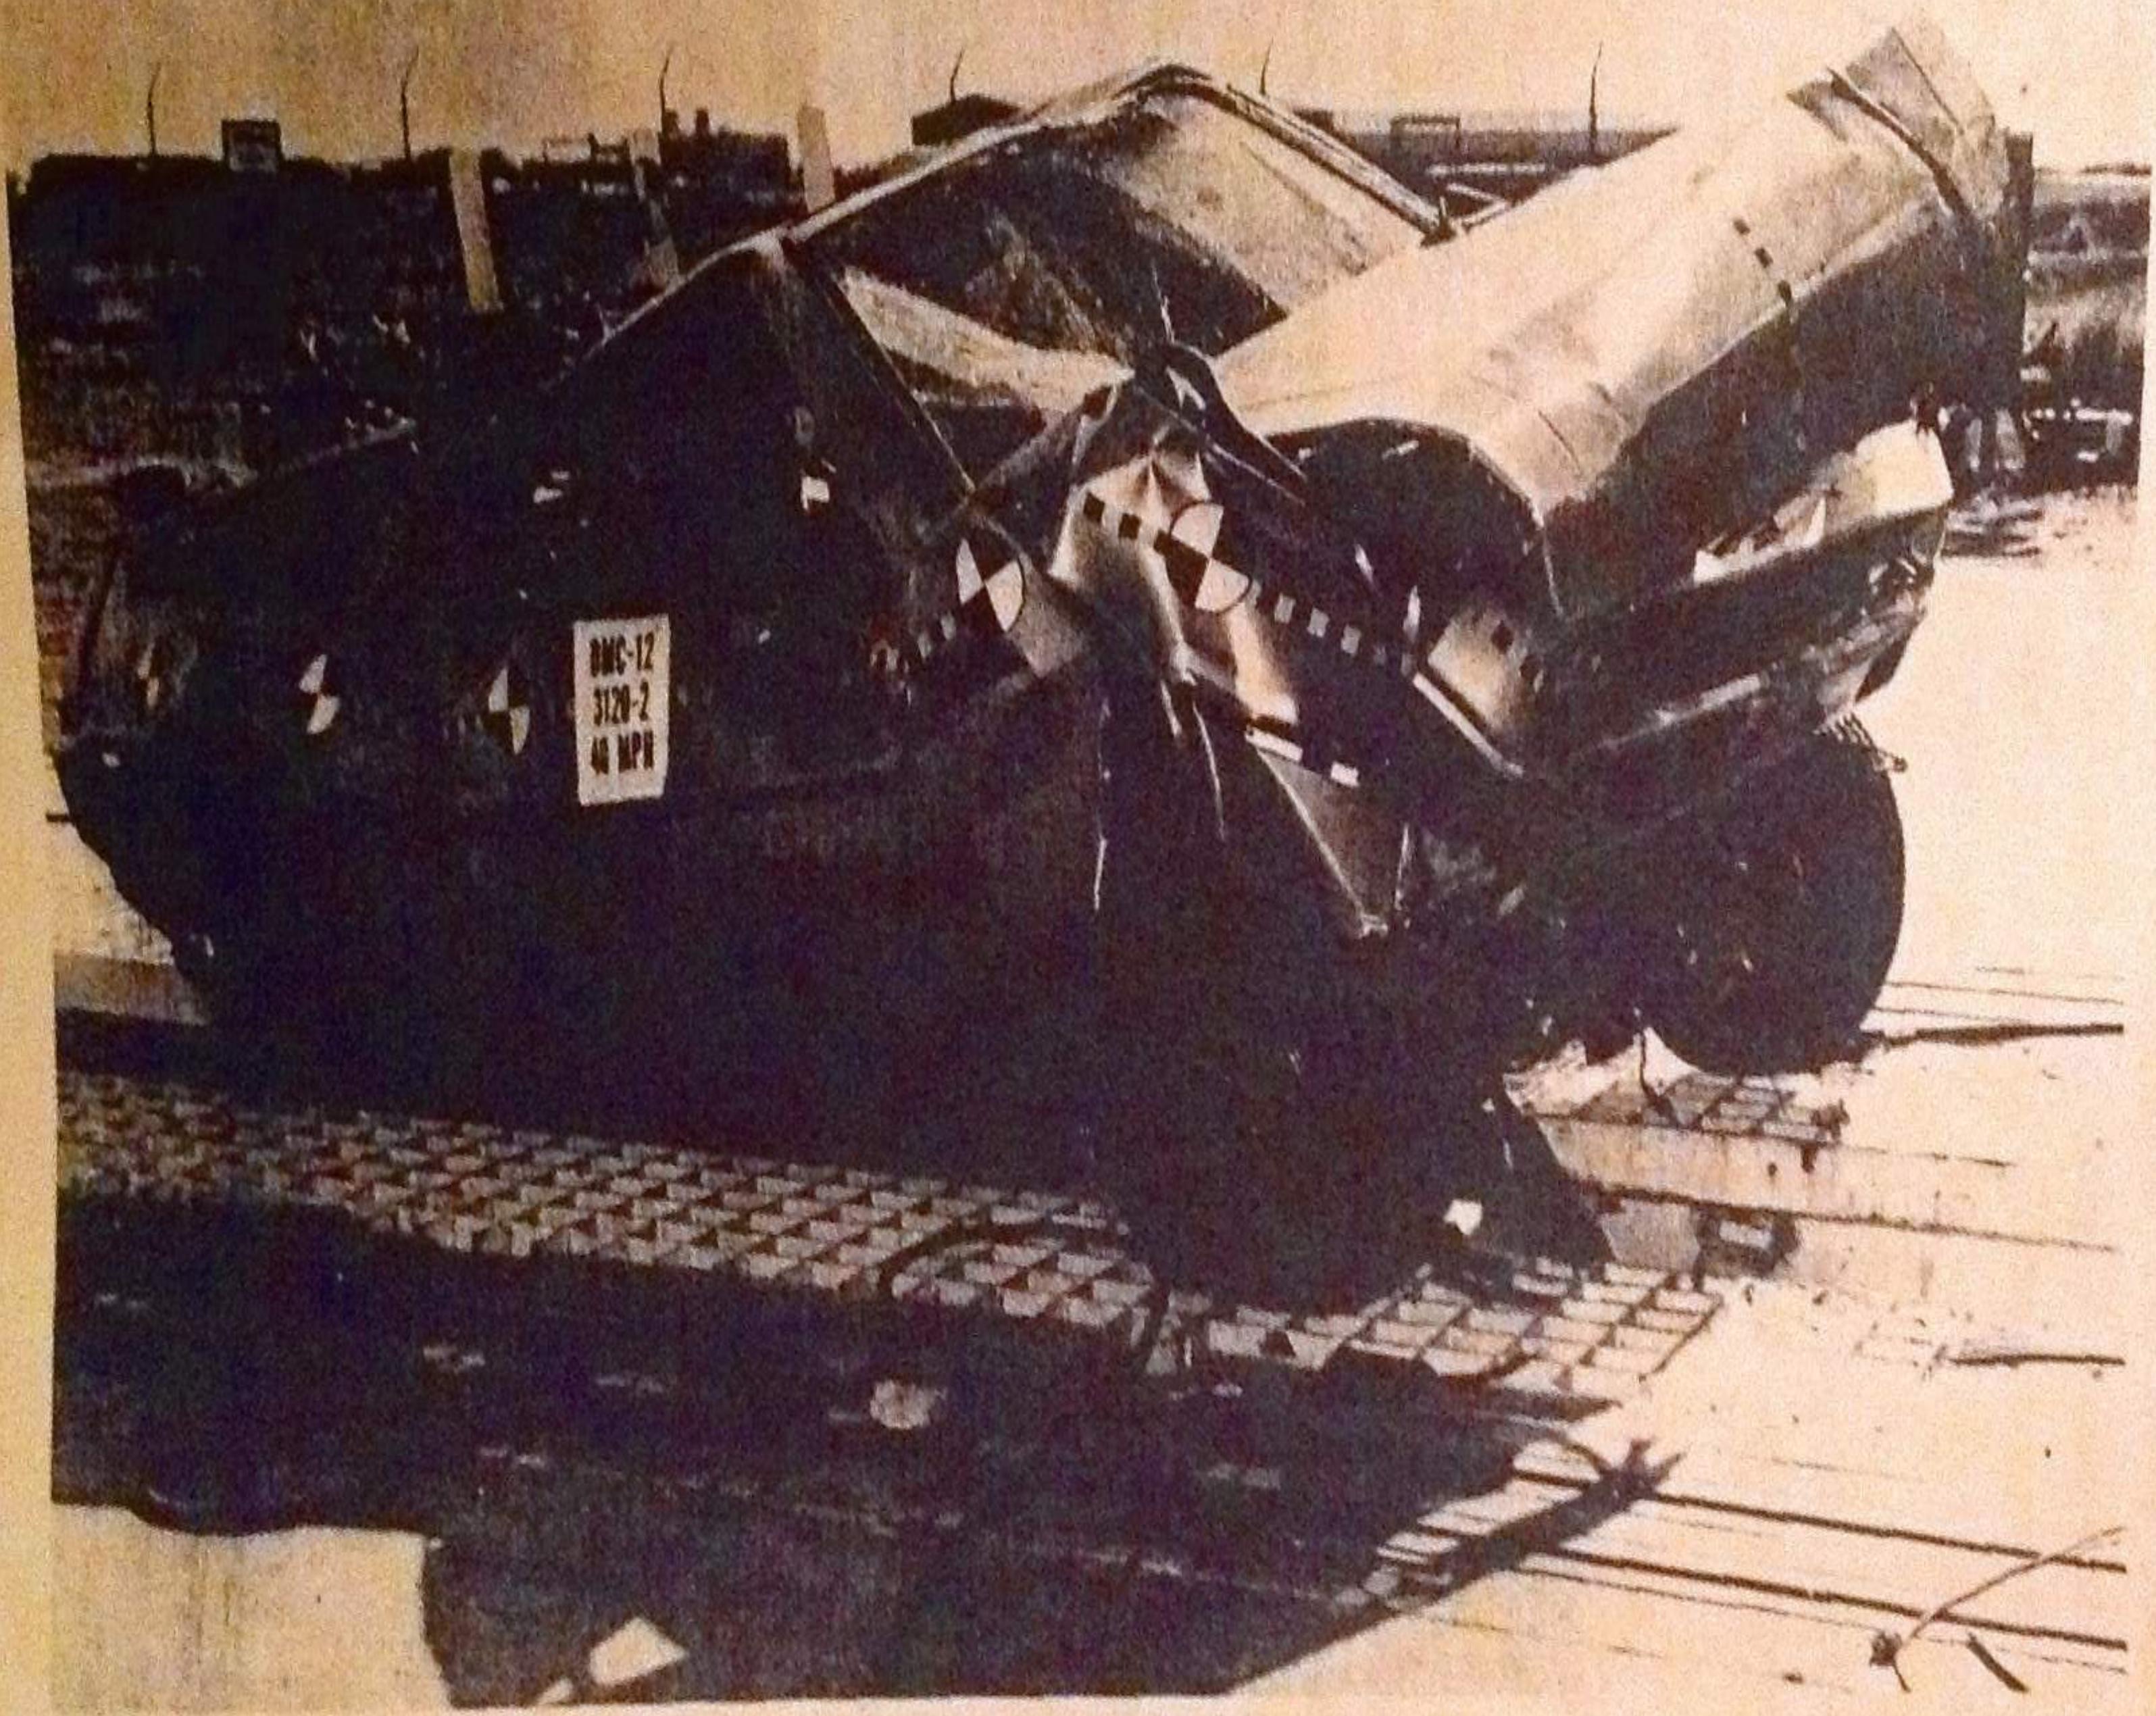
Figure 41.

Although the outward appearance of the crashed vehicle looks as if the crash was quite severe (Figures 39 through 41), the opposite is true. The vehicle crushed approximately 44 inches but the intrusion into the passenger compartment was again
