DeLorean Crash Test No. 1
36 MPH Frontal Barrier Test

4.2 Crash Test No. 2

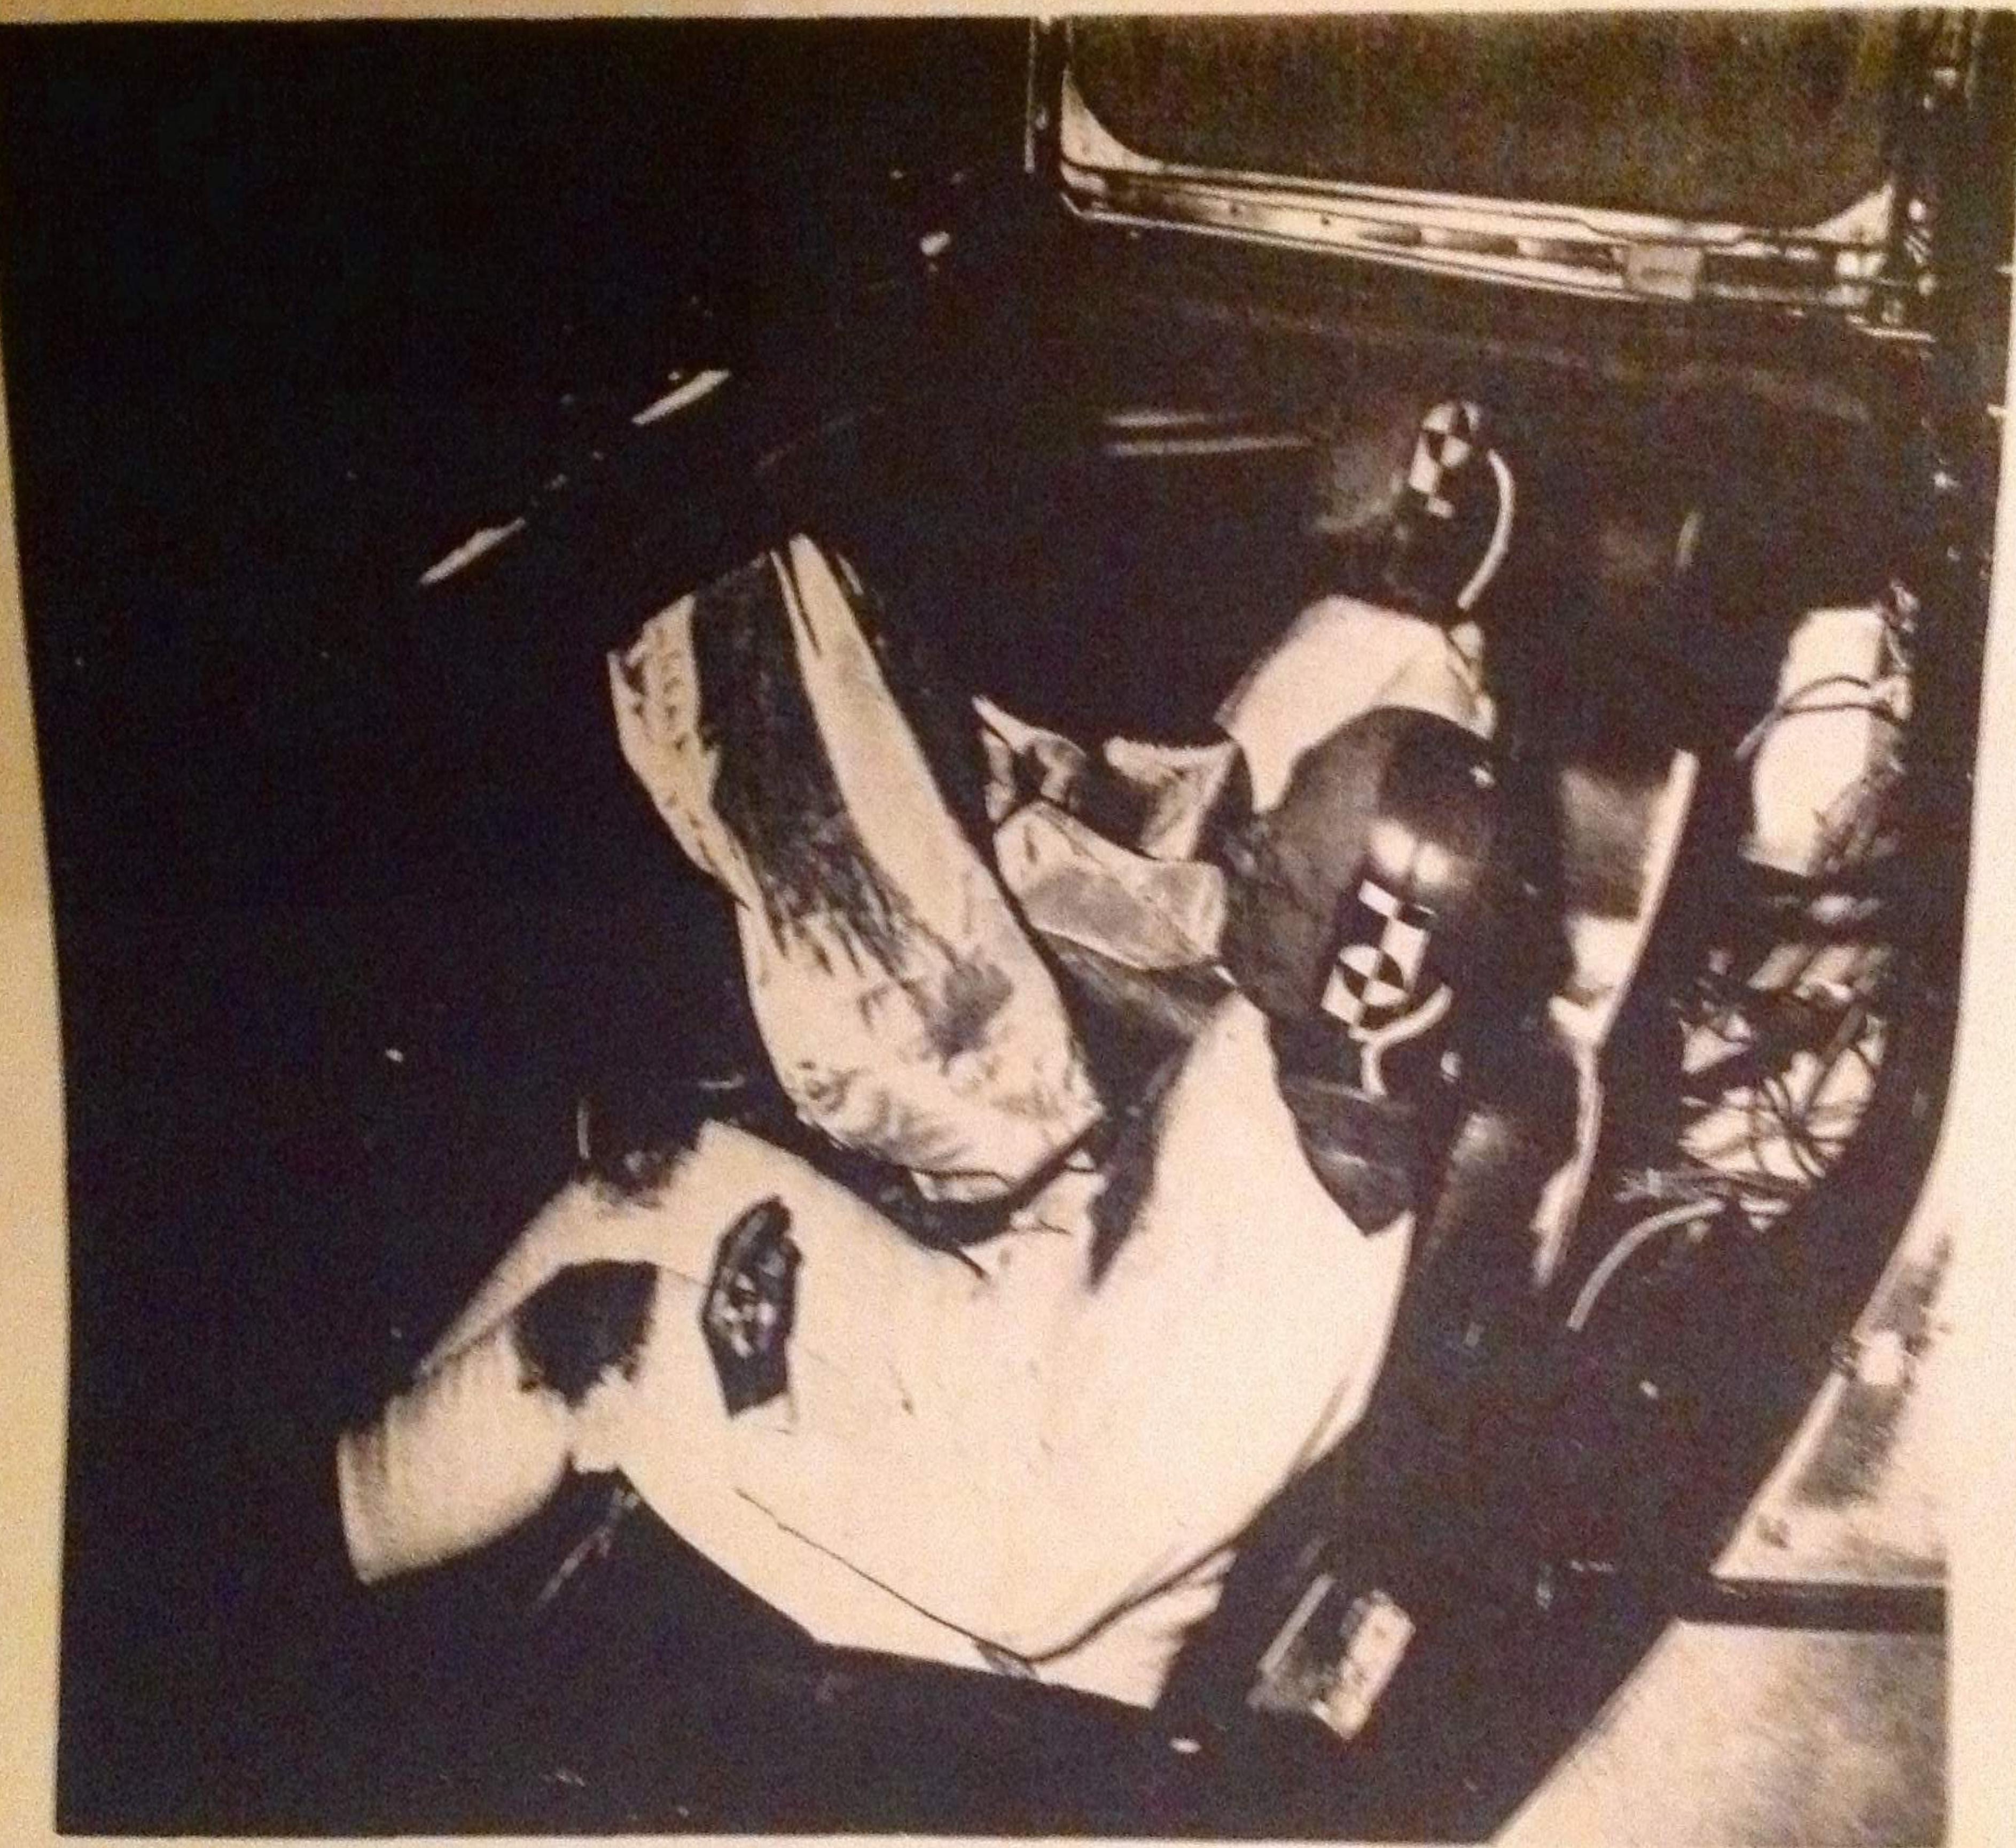
Figure 29.

Figures 24 through 34 show the vehicle, dummies and restraint systems following the crash. There was only light-to-moderate structural intrusion into the passenger compartment and, what little there was, was confined to the lower firewall and toe-board areas.

Vehicle Interior, Post Test No. 1

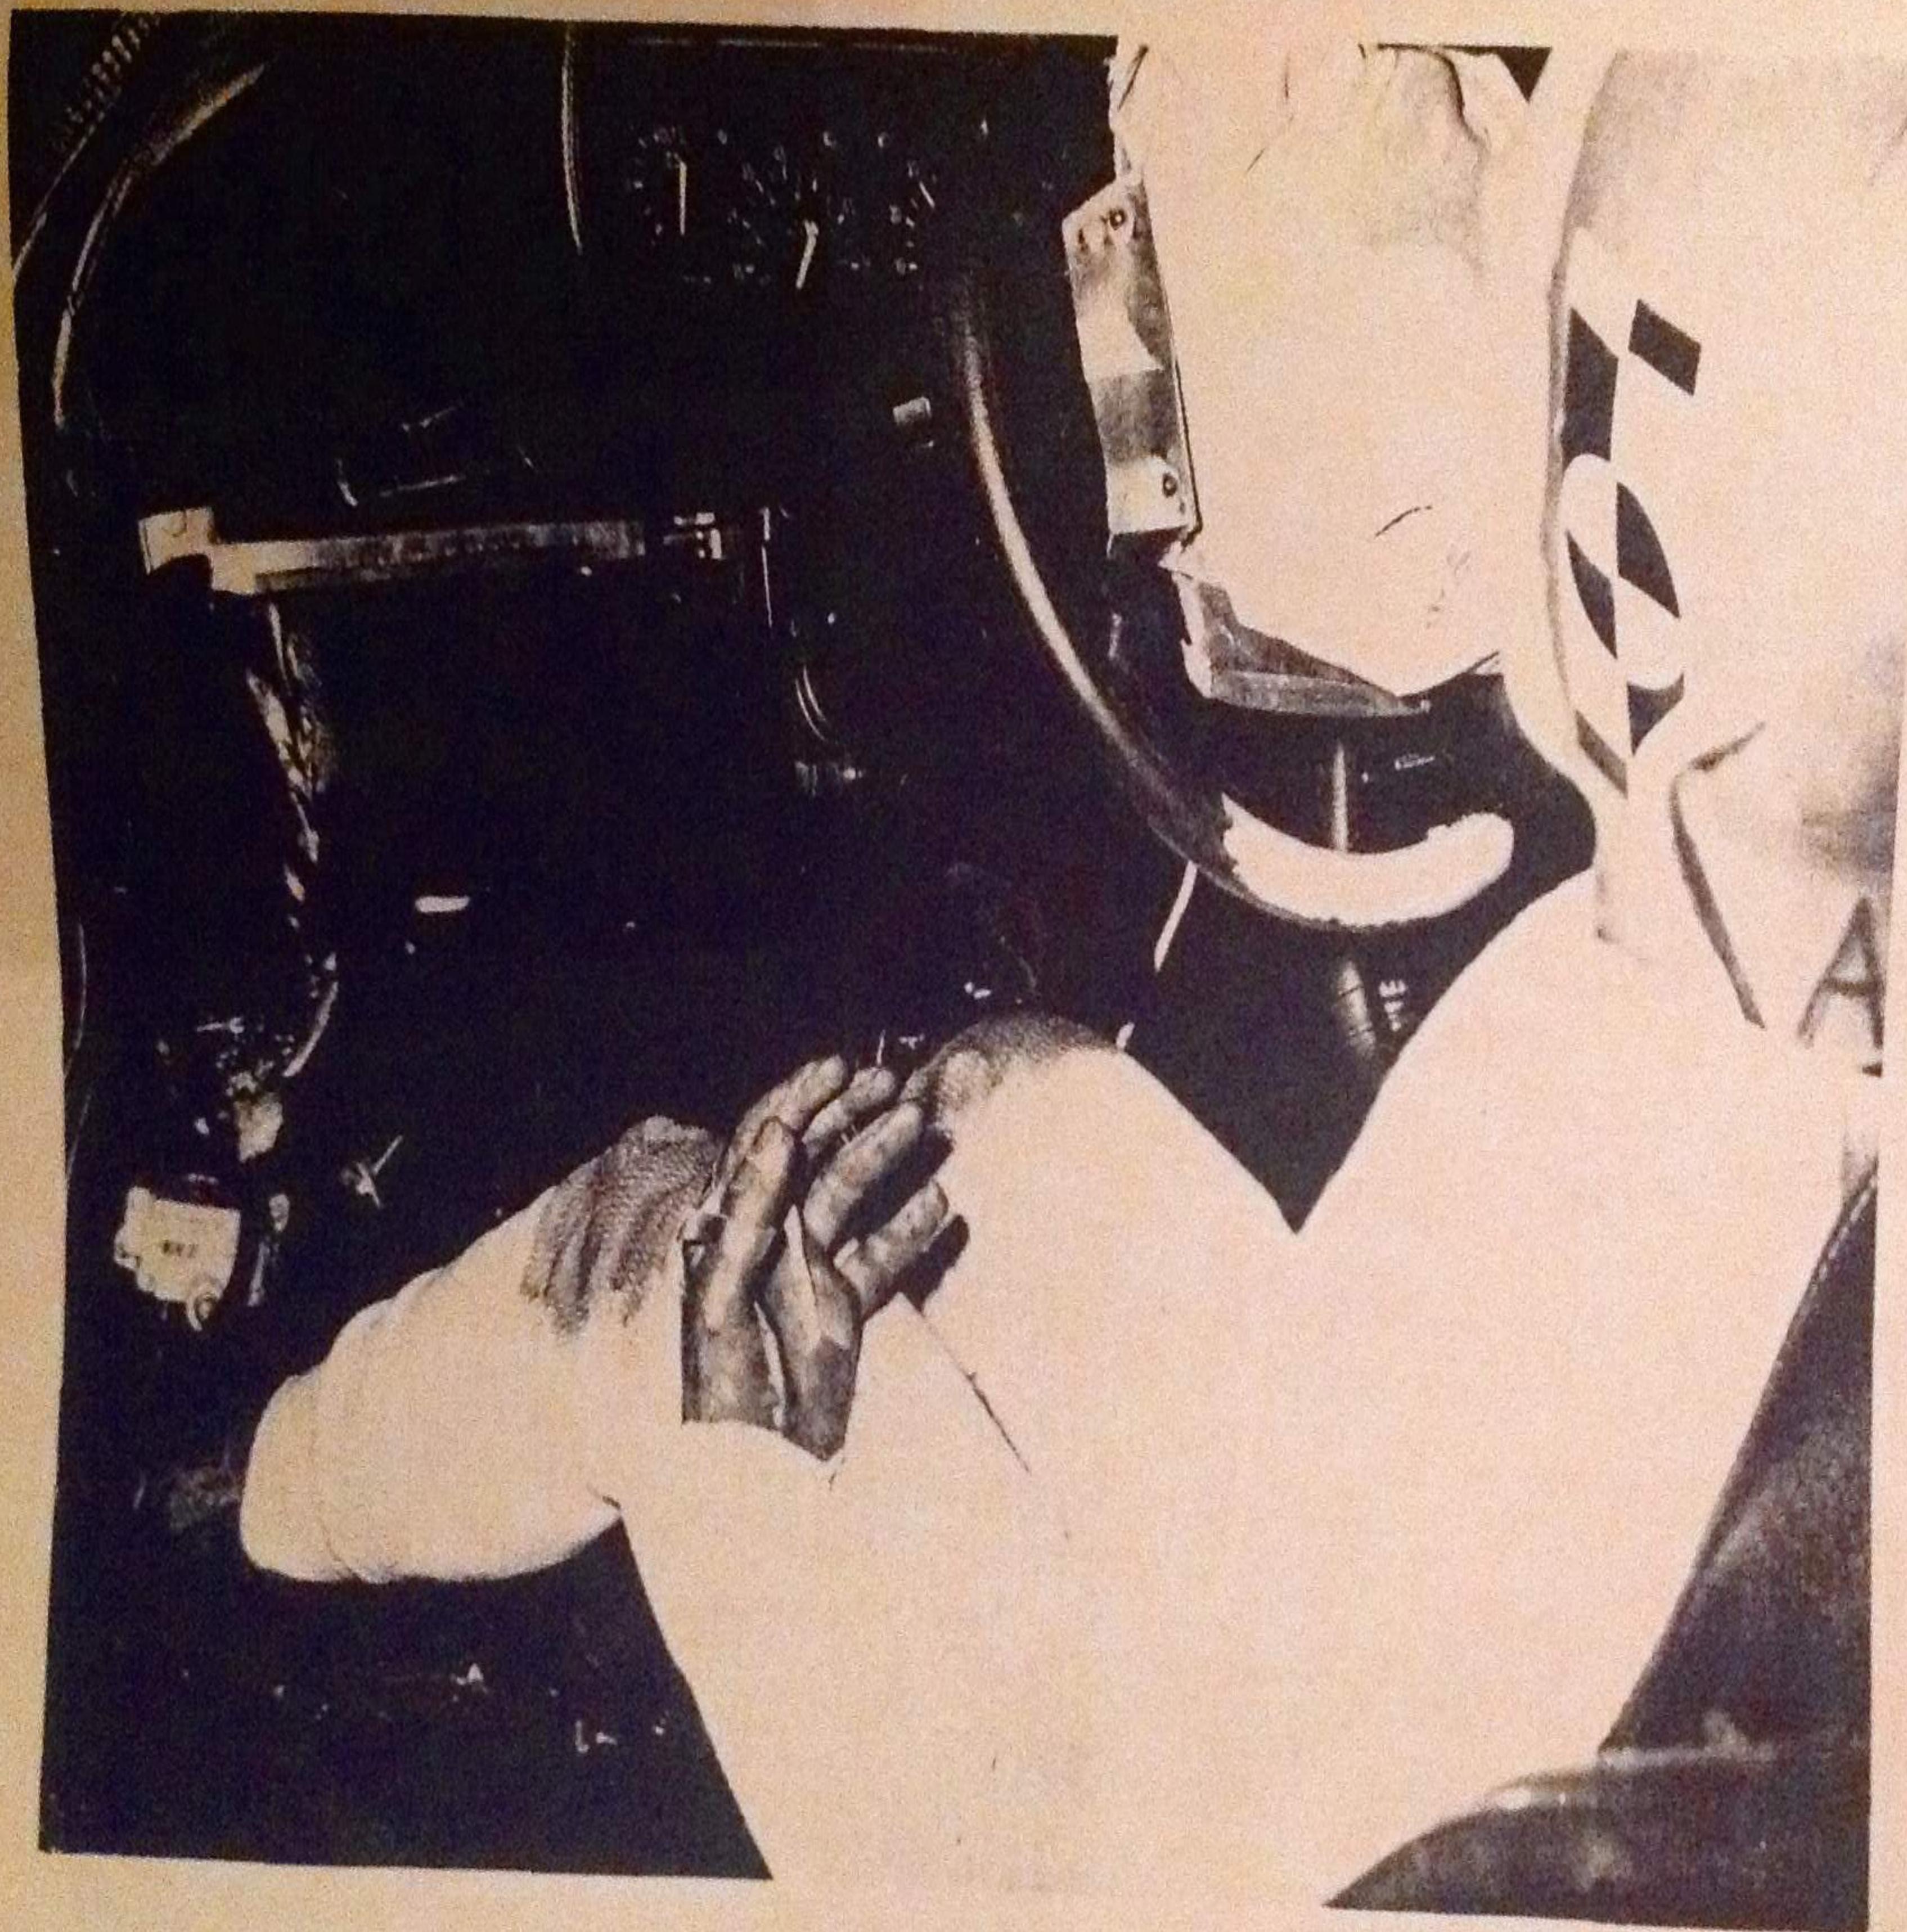
Figure 30.

First, the driver "submarined" somewhat and, due to the non-stroking column used in this first test, his head was pushed rearward relative to the torso quite severely. Additionally, the driver H-point moved forward and then abruptly downward as the knees became imbedded in the knee restraint. This also contributed to the submarining tendency.

Driver Restraint System, Post-Test No. 1

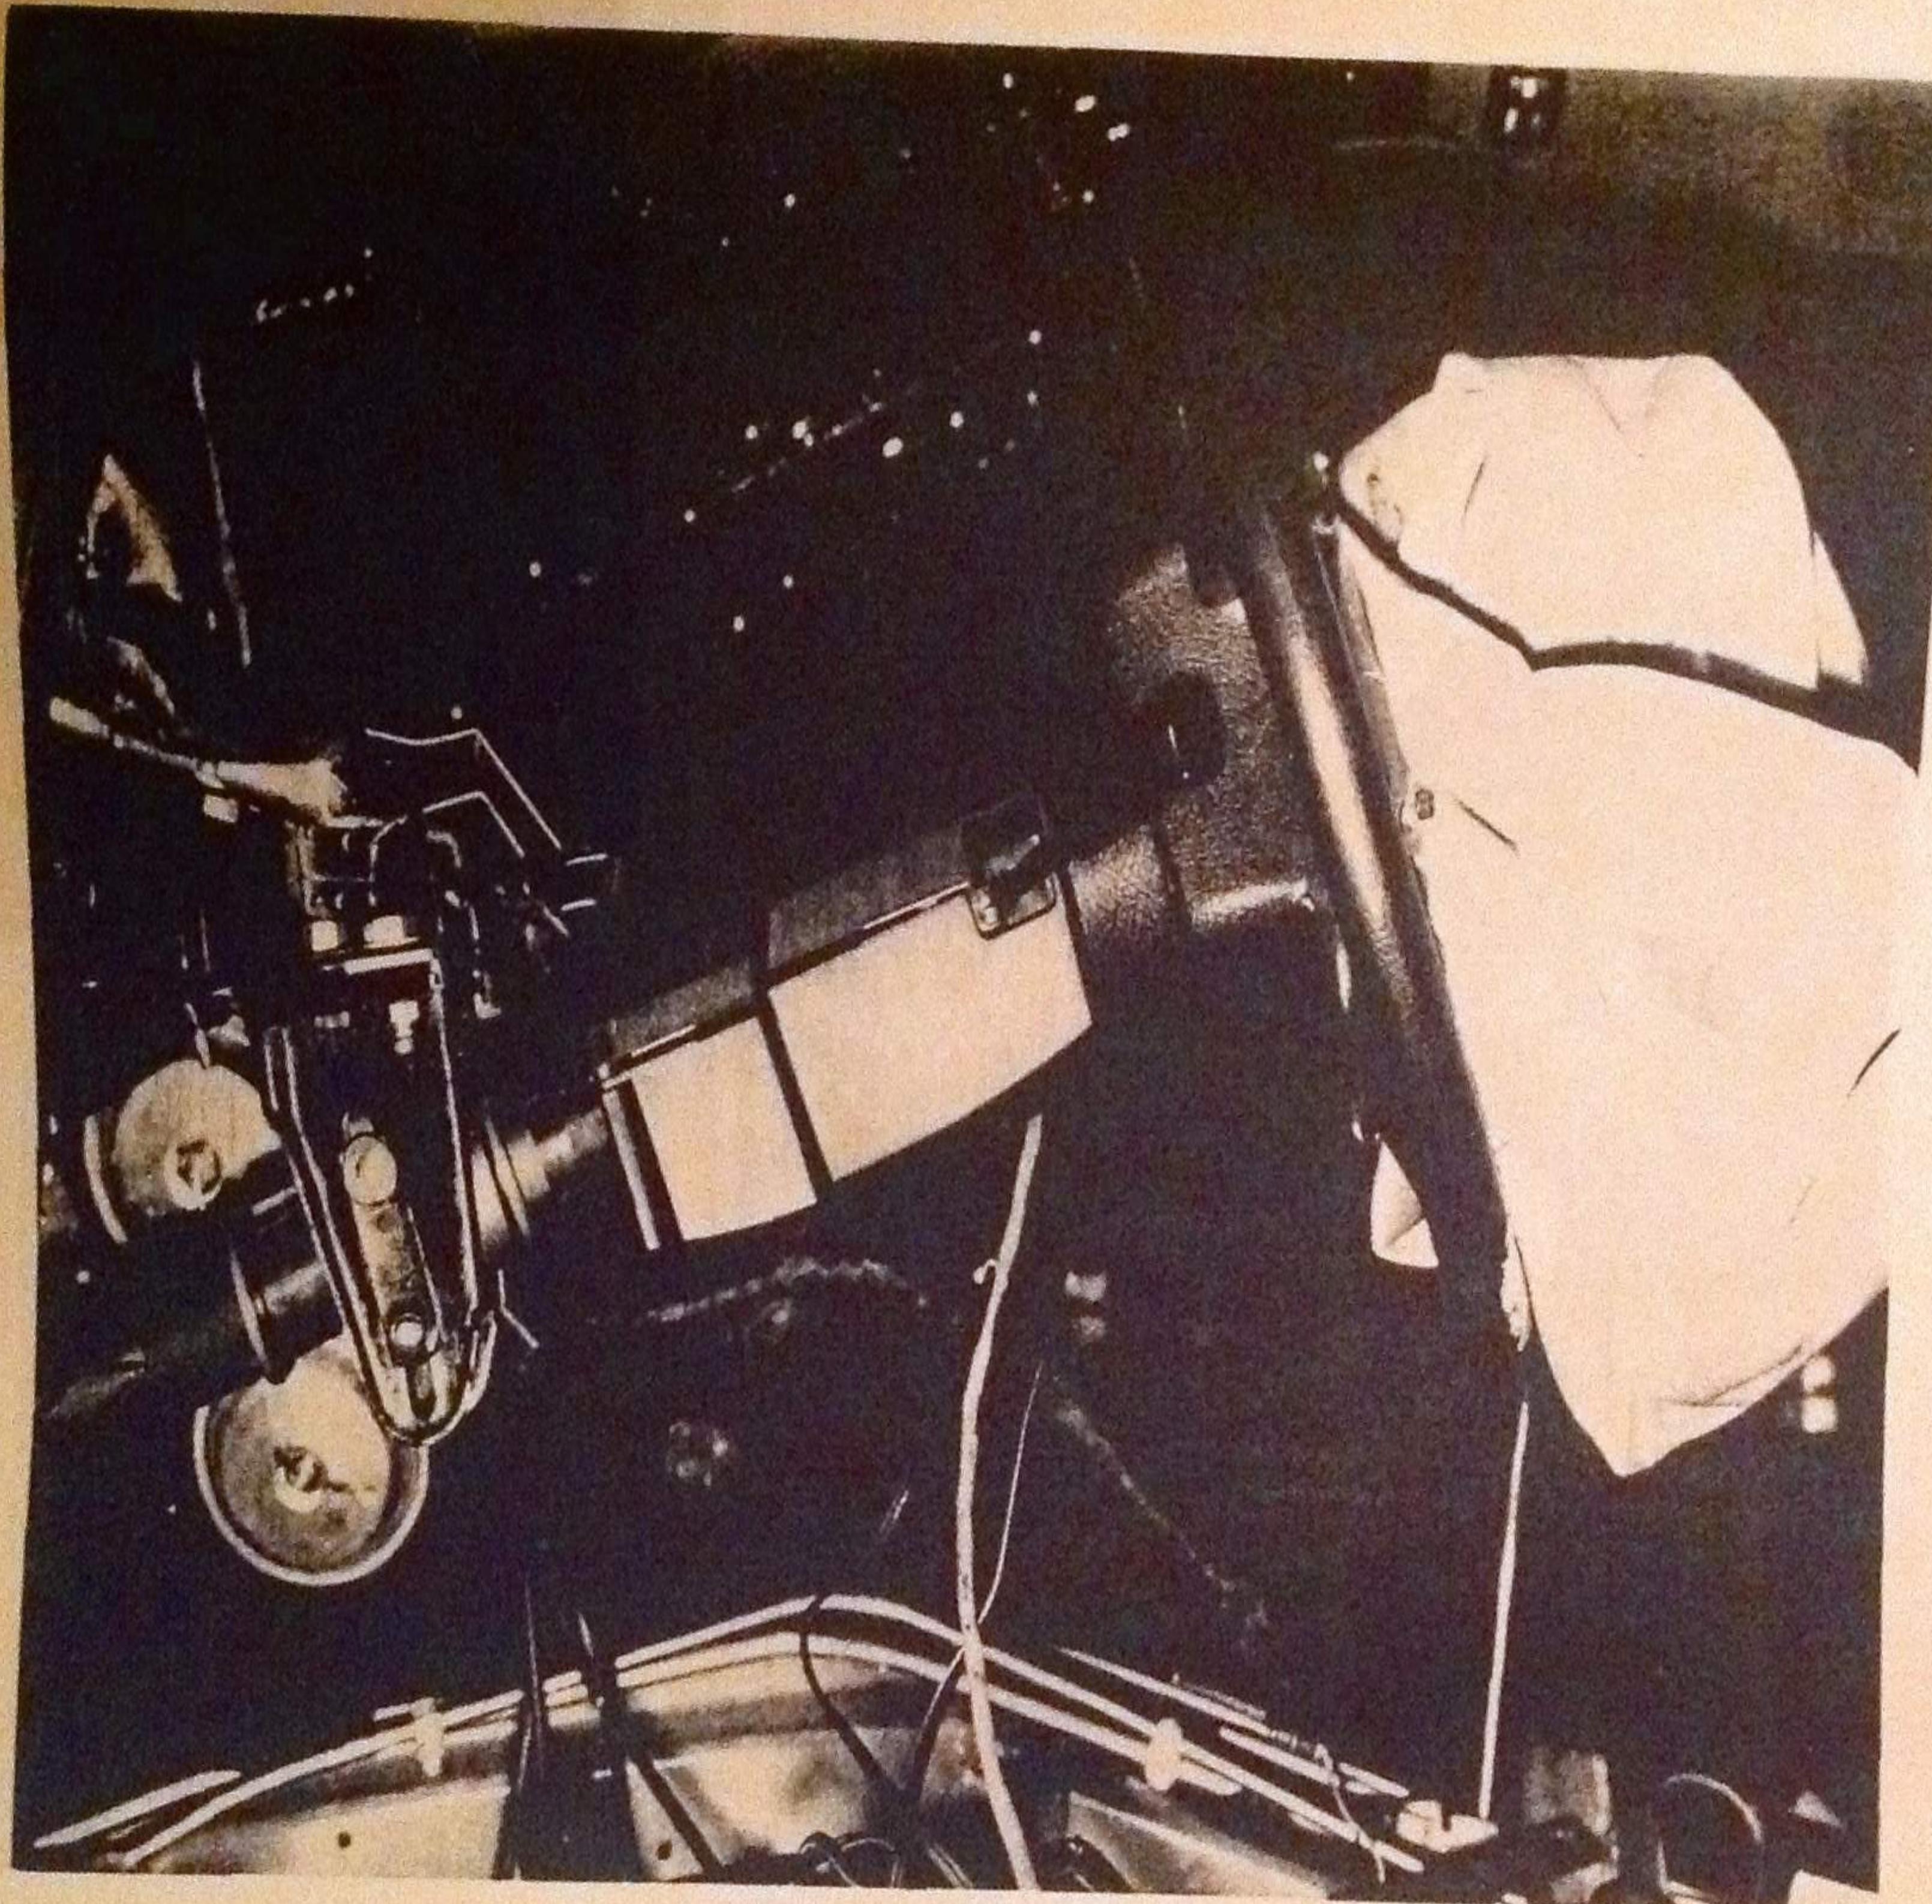
Figure 32.

During this test the steering wheel crushed approximately two inches and the column rotated upward $10\frac{1}{2}$ degrees from its initial angle of 14 degrees from horizontal. In addition, the intruding firewall crushed approximately two inches of the expanded mesh E/A unit of the column (Figure 6).

Driver Restraint System, Post-Test No. 1

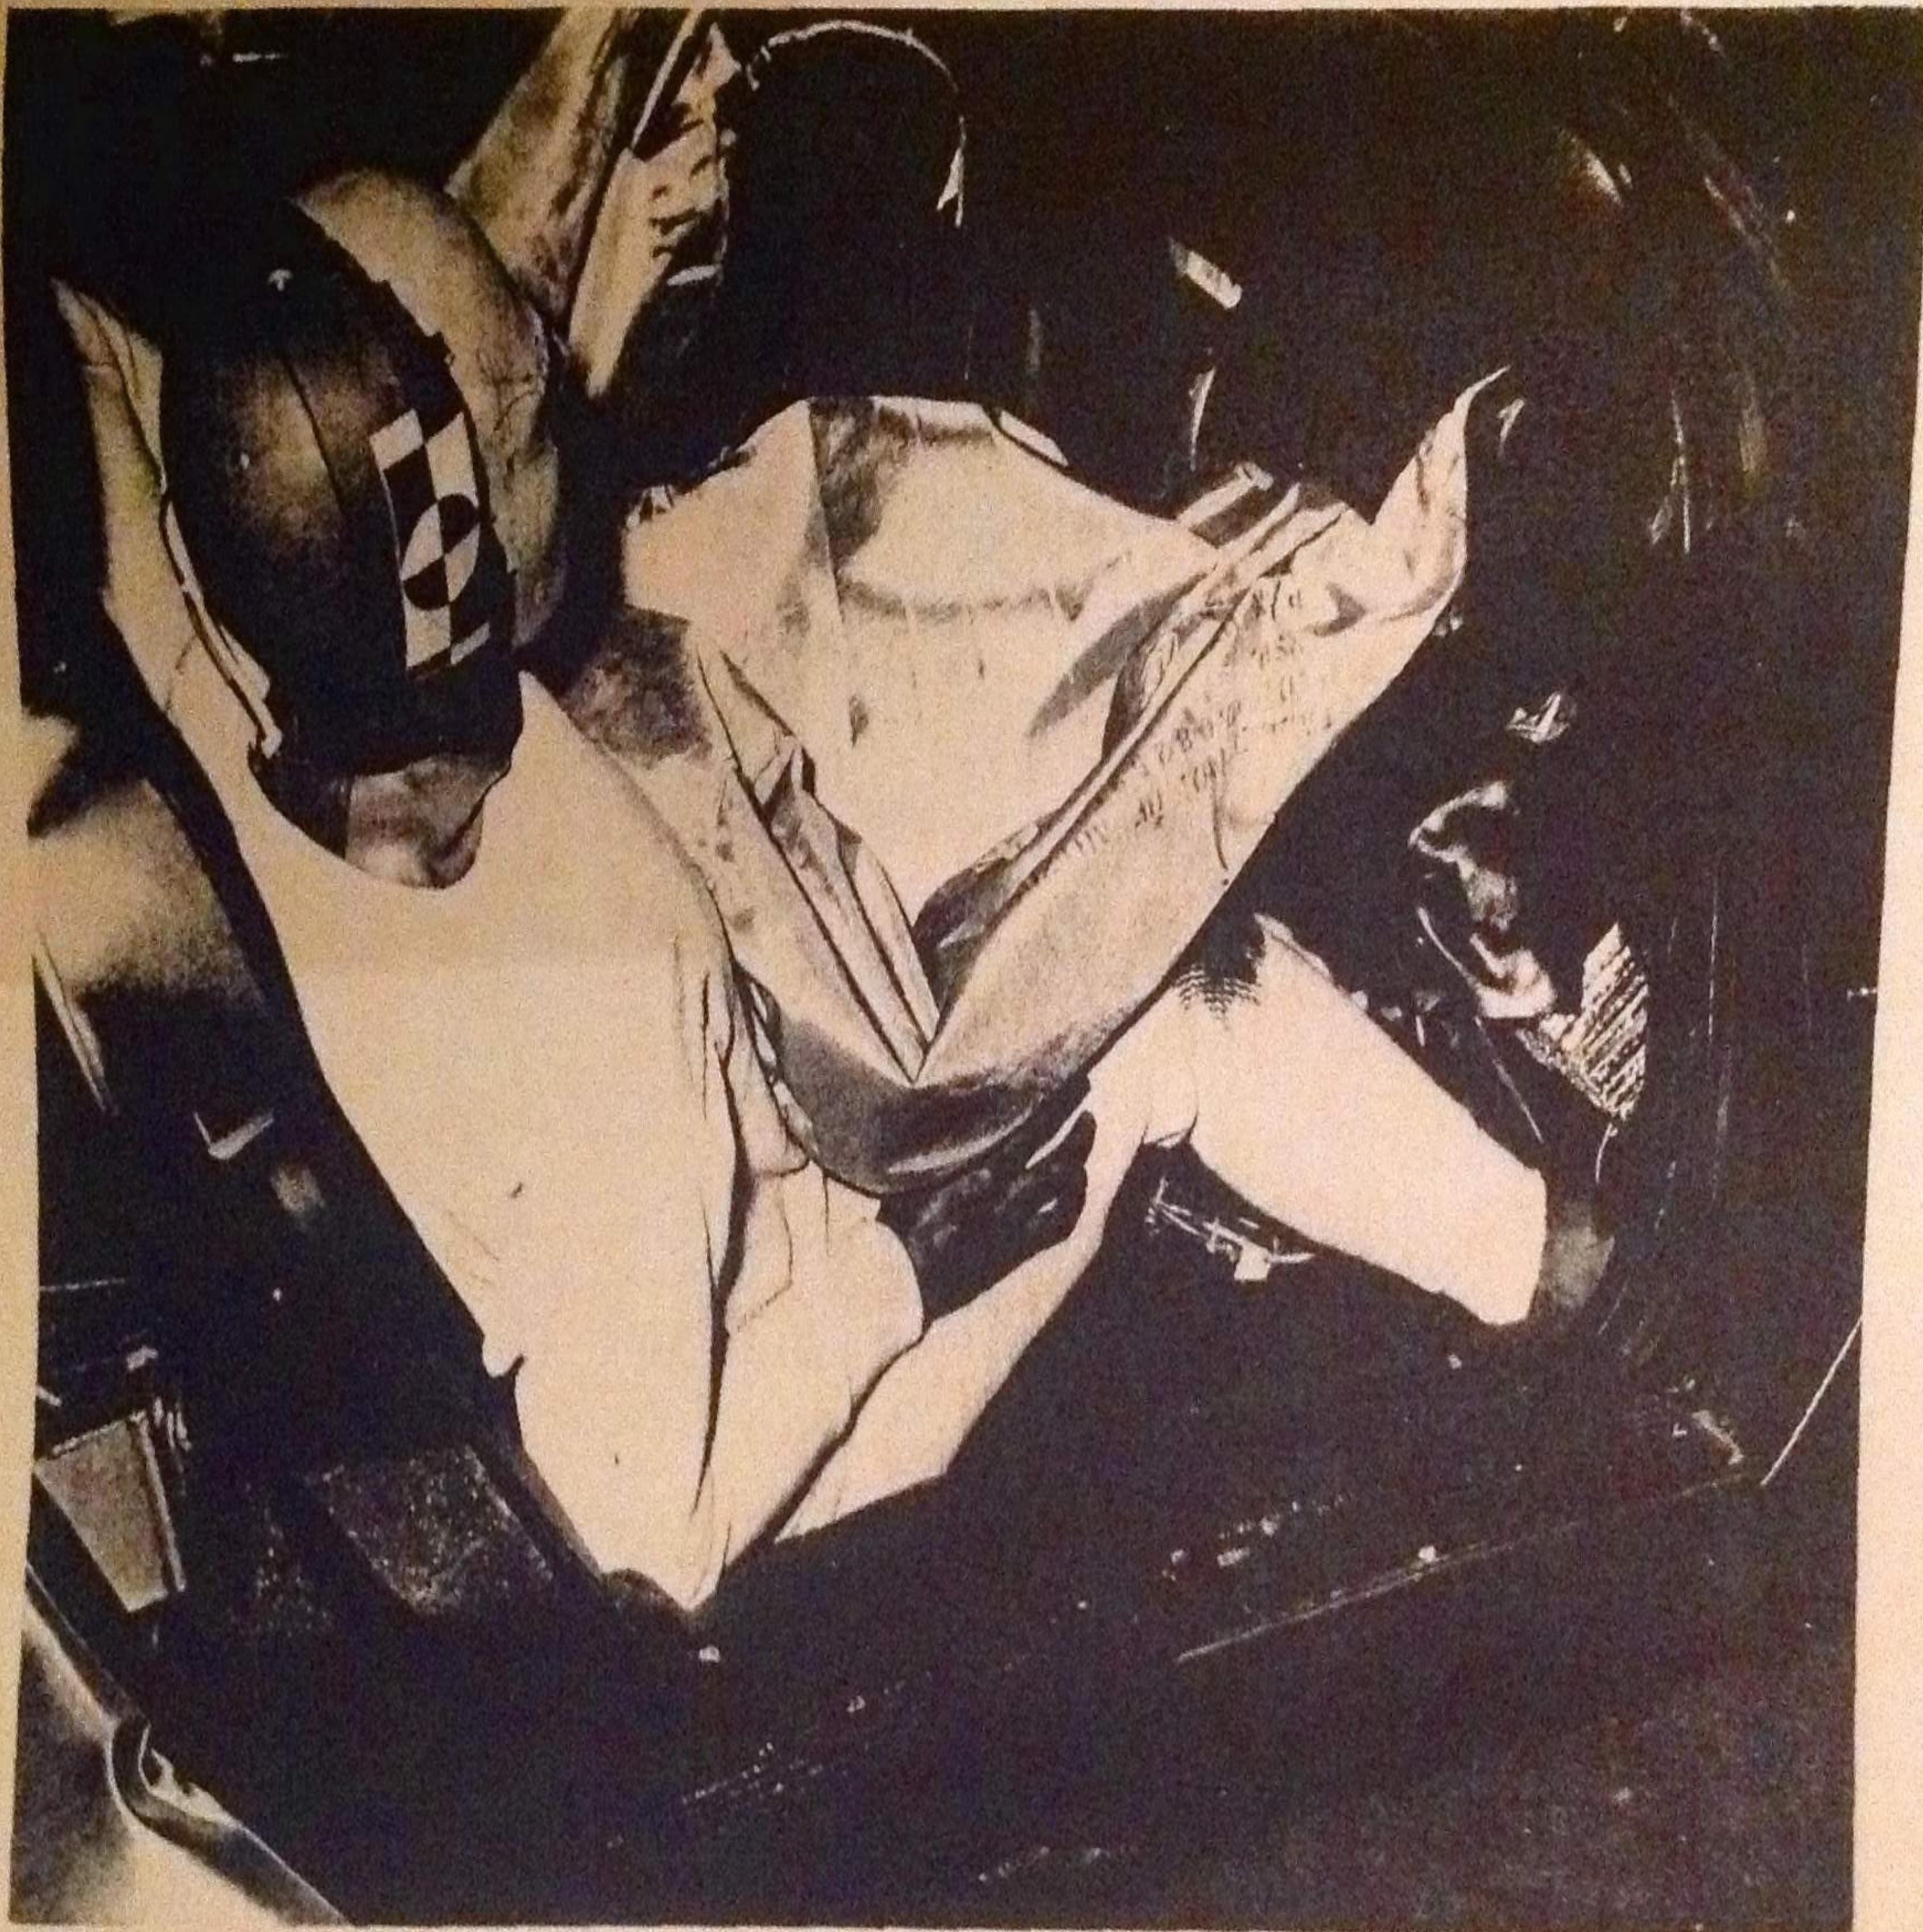
Figure 33.

Second, the passenger moved to the outboard side of his airbag, rotating in a counter-clockwise direction when viewed from above; i.e. so that he faced toward the driver somewhat.

to the fact that the passenger's module pan containing the gas generators and the airbag were not pointing the airbag at the center of the passenger's chest but was, rather, pointing toward the passenger's left shoulder. The reason for this was that although the module pan was centered on the chest in the fore-aft direction, it was also canted to follow the dash contour thereby aiming the airbag toward the left shoulder.

Passenger Restraint System, Post-Test No. 1

To fix this prior to the next test, we merely rotated the module pan until its plane was perpendicular to the direction of vehicle travel. The effect of this rotation was that a line perpendicular to the center of the module pan now passed through the chest center.
